## Energy Efficient Renovations Of Storm Damaged Residences - Florida Case Studies

# Energy Efficient Renovations of Storm Damaged Residences - Florida Case Studies

**FSEC-CR-1648-06**

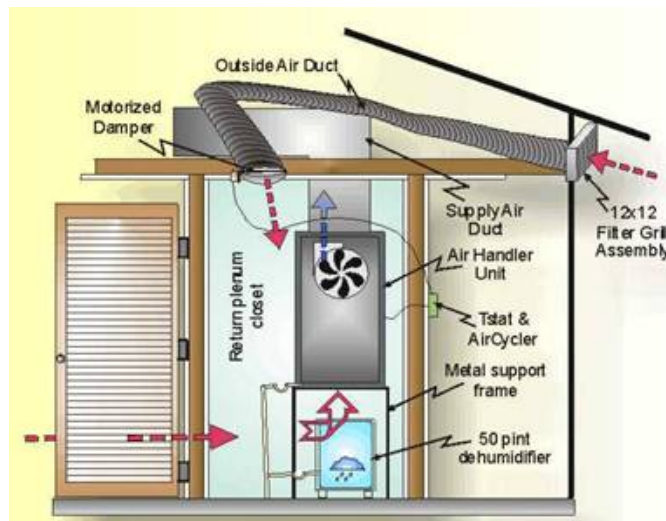
The use of the unvented attic which reduced the Air Changes Per Hour at 50 pascals (ACH50) from 10 down to 6 has caused the homeowner to consider adding mechanical ventilation for better perceived indoor air quality. The owner has also been considering the addition of supplemental dehumidification for enhanced comfort. Spot ventilation is present via bath fans, windows, and exterior vented kitchen range hood to remove intermittent sources of humidity, but it is rarely used. The owner has purchased equipment and installed necessary ductwork to implement the mechanical ventilation / supplemental dehumidification scheme shown in the following figure, but has not yet made the scheme operational.

**Figure 2 Dehumidified Return Plenum w/AirCycler Control**

50 pint per day dehumidifier	180
6” flex duct – 25 feet	41
10” x 10” ductboard box	12
10” x 10” filter back grill w/pleated filter	21
6” duct collar with manual damper	8
<i>homeowner purchased</i>	<b>Total</b>
	<b>\$ 262</b>

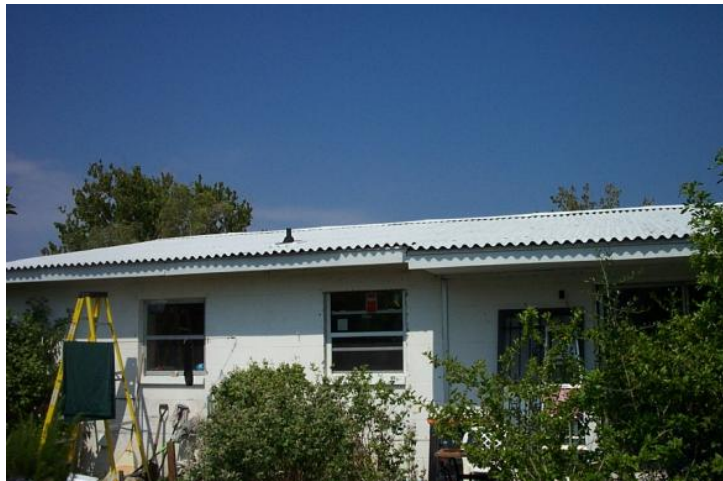
**Figure 5 Finished light colored composite roof panels installed**

Remove existing roof	<i>Price not broken down</i>
Apply synthetic underlayment	
Apply batten system	
Install drip edge, flashings, boots, kitchen vent and ridge cap	
Install light fiberglass composite panel roof	
<b>Total (approximate)</b>	<b>\$ 15,000</b>

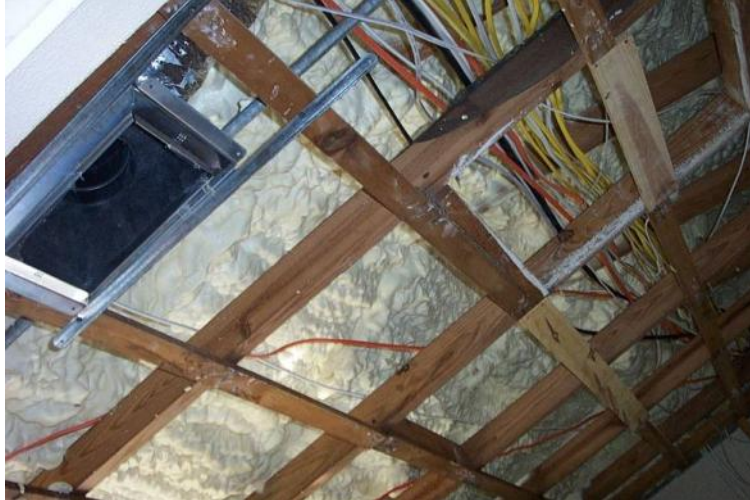
**Figure 6 Sealed attic with spray foam insulation (Icynene™). Note the duct work is below the insulation, which places it within the air & thermal boundaries.**

5 ½ inches (R-22) Icynene™ foam under pitched roof (~\$2/sqft)	\$3180
<b>Total</b>	<b>\$ NC</b>
Material and labor costs were donated by Icynene to research post retrofit energy consumption
