Building Envelope Air Leakage Failure In Small Commercial Buildings Related To The Use Of Suspended Tile Ceilings

Building Envelope Air Leakage Failure in Small Commercial Buildings Related to the Use of Suspended Tile Ceilings

Charles R. Withers Jr. and James B. Cummings

FSEC-PF-398-00

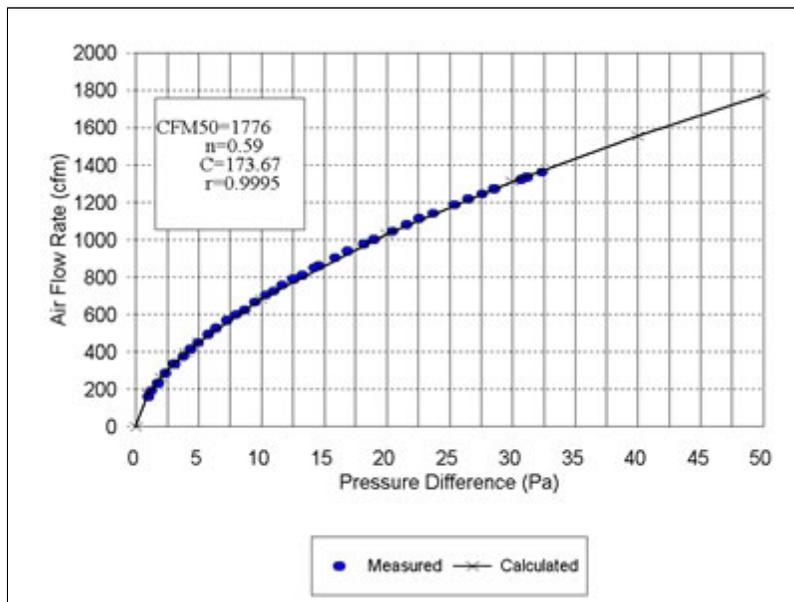
Figure 1. Ceiling Airtightness Flow Curve

Figure 1 shows a plot of the air flow versus airtightness of the ceiling. The amount of leakage is measured as airflow in cubic feet per minute when the building is depressurized to 50 Pa also known as CFM50. The CFM50 of the room was 1776. The variables n and C are shown in figure 1 and can be used to calculate airflow for the building if the pressure is known using the equation $Q = C \times dP^n$ where Q is airflow, C is the flow coefficient, n is the flow exponent, and dP is the differential pressure. The normalized airtightness (mentioned previously as ACH50) is 33.6. ACH50 was calculated as follows: $1776 \div 3168 \text{ ft}^3 \text{ room volume} \times 60 = 33.6 \text{ ACH50}$. When the ceiling tightness is normalized by the square foot area of the ceiling, CFM50 per square foot of ceiling area is 5.0.

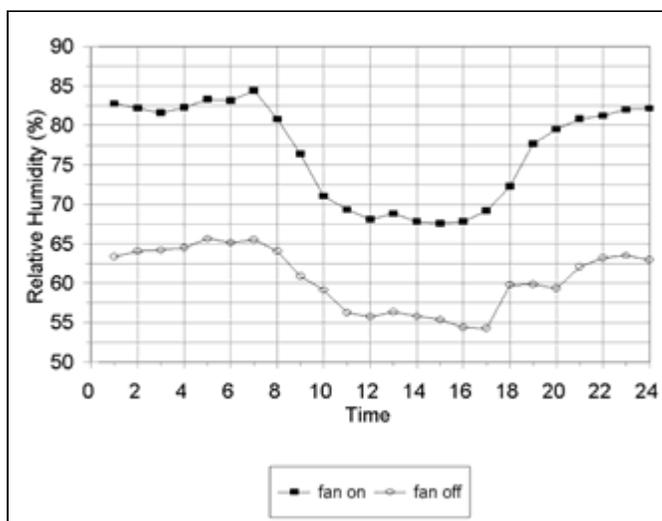
Figure 2. Relative Humidity in Office

After duct repairs were complete, the building ventilation rate declined slightly from 0.87 air changes per hour (ach) to 0.79 ach and CFM25 in the ducts decreased by 80% from 571 to 112. Notice in Table 1 the indoor relative humidity increased because air conditioner run time decreased by about 30% while the building ventilation rate remained largely unchanged. Building depressurization did not disappear until the attic exhaust fan was turned off. Turning off the attic exhaust fan also caused daily relative humidity levels to decrease from 77% to 61% and from 68% to 55% during normal business hours of 11 AM to 5 PM (Figure 2). It also caused the building ventilation rate to decreased from 0.79 ach to 0.33 ach.

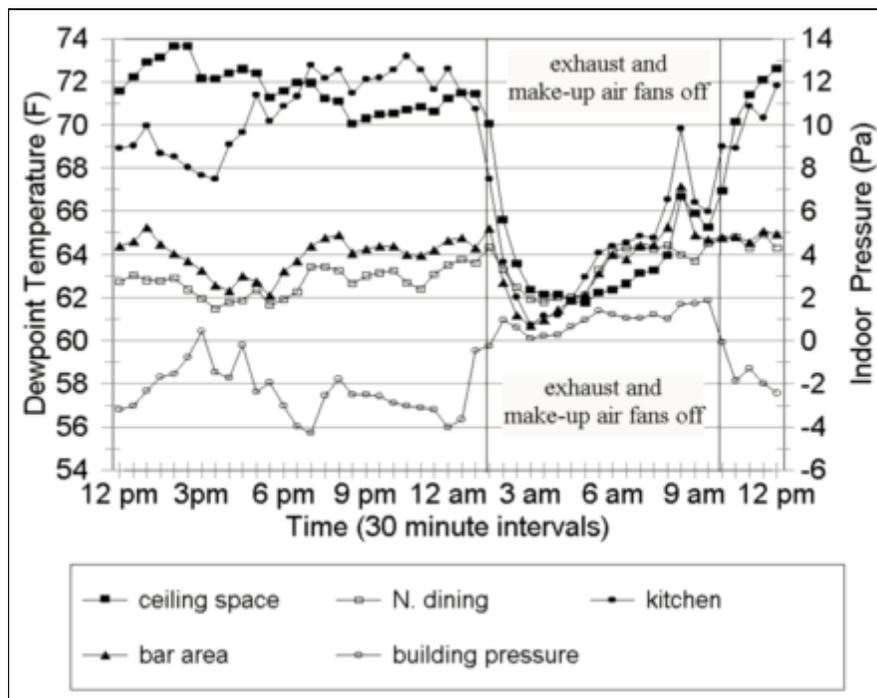
Figure 3. Restaurant Dewpoint Temperature and Pressure With Reference to Outside With Kitchen Fans On and Off

Preliminary testing and inspection found the building to have an airtightness of 12,021 CFM50. This calculates to an ACH50 of 14.1 based on an occupied conditioned space of 6061 square feet with ceiling at 8.5 feet. This building was tighter than the average of 69 small commercial buildings mentioned previously. The primary air and thermal barriers were identified to be at the roof deck. When the building was depressurized to 50 Pa with reference to outside, the ceiling space was -42.9 Pa with reference to outside. The pressure drop across the ceiling was only 7.1 pa. The building normal operating pressure, which is the indoor pressure with reference to outside when all RTU's are on, kitchen exhaust, and make up air fans are operating, was -2.7 Pa. The dishwasher exhaust only operates part time so it was not turned on, however the building pressure becomes -5.0 Pa when it is turned on. The negative building pressure indicates that the total exhausted air from the building exceeds the total incoming air. Short-term monitoring of space conditions revealed interesting findings for this building about unbalanced exhaust flow and leaky ceilings as is shown in Figure 3.

Monitoring for several days showed the same pattern repeated daily. Workers would turn on the kitchen exhaust between 9:00 and 9:30 am and turn them off about 1:00 am. The ceiling space and conditioned space dewpoint go up drastically when the kitchen exhaust fans were turned on and would drop after the exhaust was turned off. When the exhaust fans are turned on, the ceiling space dewpoint increases to values near the outdoor dewpoint indicating this space becomes filled with outside air. The building operated at about -2.7 Pa due to the unbalanced exhaust air of the building. This caused the ceiling space to also be depressurized about the same amount. Although the primary air barrier is at the roof deck and walls of the ceiling space, this does not mean it will act as a good air barrier. In fact, all around the perimeter walls of the ceiling space there are significant pathways between the ceiling space and the exterior vented soffit space. Notice also in the figure that the building pressure becomes positive once the exhaust fans are off and the ceiling space dewpoint becomes drier as conditioned air is pushed up through the ceiling into the space. This is due to more air being brought into the restaurant from the outside air than what is being exhausted.

A retrofit plan was developed that included recommendations to reduce kitchen exhaust flows to a minimum amount that would still effectively capture all cooking effluent. Capture would also be improved by increasing make-up air flows to 80 % of the exhaust flow and modifying delivery of make-up air so that it is discharged outside the hoods. The outdoor air should be enough to satisfy ventilation requirements and at least 21 % of the exhaust flow. The last recommendation was to air tighten the ceiling space. With these changes, the building would be more airtight, operate under a significant positive pressure, and the ceiling space would then maintain lower relative humidity thereby preventing further damage to the ceiling tiles.

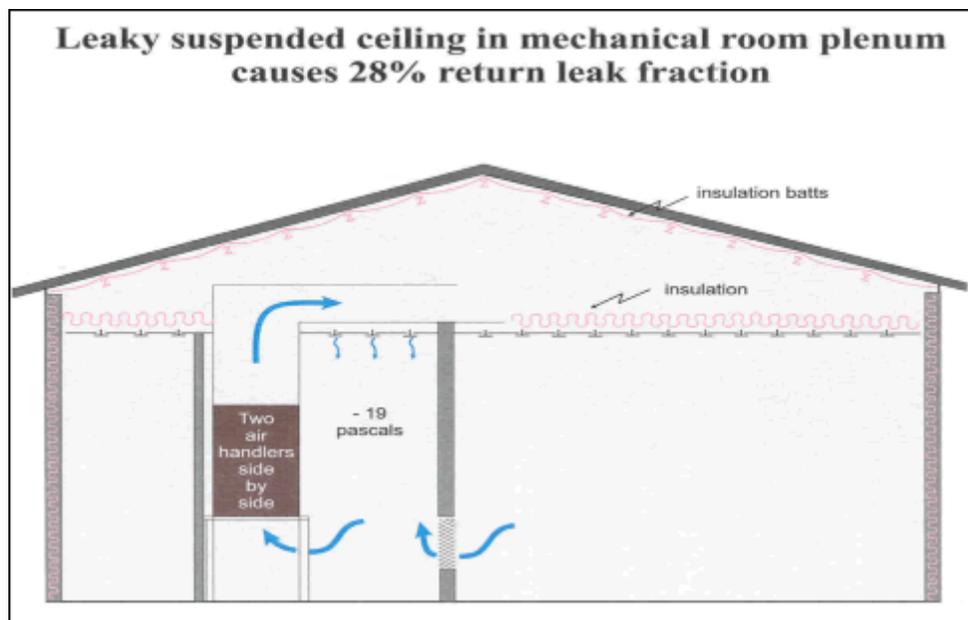
Figure 4. Airflow Failure Through Suspended Ceiling in Room Used as a Return Plenum

The building was air conditioned using two air distribution systems with all supply ductwork located in the ceiling space. The west system air handler was located in the ceiling space with a return ducted to a main hallway, however, the east system air handler was located on top of an unfinished support platform in a mechanical closet that was used as a return. A transfer grill from the room to the main hallway served as the pathway from the building back to the air handler. Use of the mechanical room as a return plenum caused it to be depressurized to -19.1 Pa wrt the ceiling space when the air conditioner operated. Since the depressurized mechanical room has a suspended ceiling, 28% of the return air was coming from this relatively hot (though dry) ceiling space (Figure 4). As a general rule, building cavities such as mechanical rooms, walls cavities, closets, storage rooms, panned floor joists, etc. should not be used as a portion of the air distribution system since they are not built to the same airtightness standard as ductwork.

The business did not want to “hard duct” the return from the hallway to the east system return because they would lose valuable storage space. Since the room had to be used as a duct, efforts were made to make it more airtight to the ceiling space. The seams in the suspended ceiling were sealed with clear caulk and several tiles were adjusted so they fit in the t-bar grid more tightly. More importantly, the room was made leakier to the hallway by installing a louvered door to replace a solid door. As a result, the mechanical room pressure decreased, from -19.1 Pa to -4.2 Pa and return leakage decreased from 28% to 4%.
