Diagnostic Test Report on Florida Power Corporation's 15-kWp Amorphous Silicon Photovoltaic System

FSEC PVDG Division

FSEC-CR-1683-99

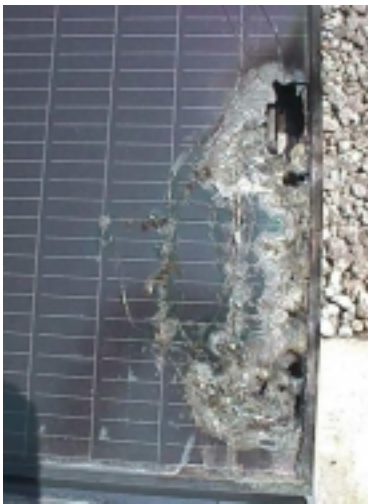
Initially, a visual check of the Solar Progress system was conducted, including an inspection of the modules, wiring, inverters and other associated equipment. Significant physical damage to two modules was immediately observed. The probable cause of the damage was the development of a virtual short-circuit condition between the PV cell and the grounded module frame, characterized by high leakage current and possibly resulting in an electric arc. The condition was such that catastrophic damage to the module glass and plastic junction box occurred, as illustrated in Figures 3 and 4.

Figure 3. Damage to the module surface.

The visual inspection of the modules indicated some level of physical damage in all five subarrays. The damage to the modules could be described as: 1) minor - chalking or corroding module frames, 2) severe - cracked module glass, extensive corrosion, and/or water present in the module, and 3) catastrophic failure of the module and materials. At least fifty-five of the 640 modules suffered from some level of damage: fifty-six had minor damage, seven had severe damage, and two suffered catastrophic damage.

1. *Minimal Cost Option:* FPC can remove about sixty failed and defective modules from the array, rewire about 10% of the connections, and get the inverter repaired by Omnion Power Engineering Corporation. The estimated cost would be up to \$5,000 for the inverter repairs, with three days labor for two technicians and one day of diagnostics for two professional staff members. The array power output will not decrease significantly as a result of this modification (less than 5% decrease).

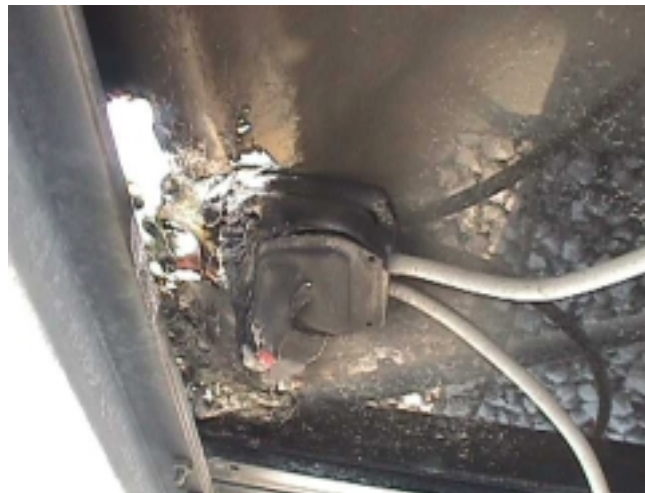
Figure 4. Damage to the module junction box.

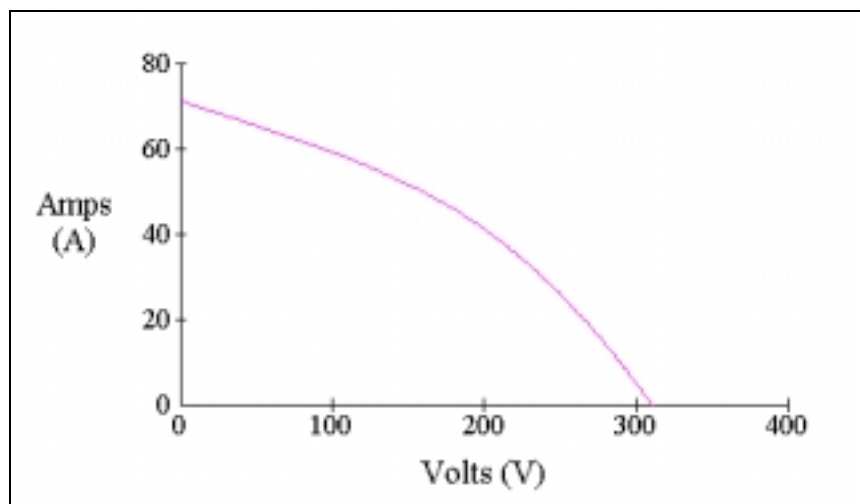
Test results for the entire array indicated that the peak power of the array was approximately 8.3kW dc and the fill factor was 37. The low values recorded for subarray 2 were primarily the result of major damage to modules. The poor performance of the subarray has a significant impact on the performance of the entire array.

Figure 5. Complete array IV curve (peak power 8.3 kW, 37.3 fill factor.)

The IV curve tests show a very poor fill factor for all of the subarrays, indicating poor performance quality of the modules. Poor fill factor can also cause problems with the peak power tracking capabilities of the inverter.
