Energy and Resource Assessment of the Caribbean Marine Research Center, Lee Stocking Island

Danny S. Parker and Michael P. Callahan
Florida Solar Energy Center (FSEC)

FSEC-CR-1085-99

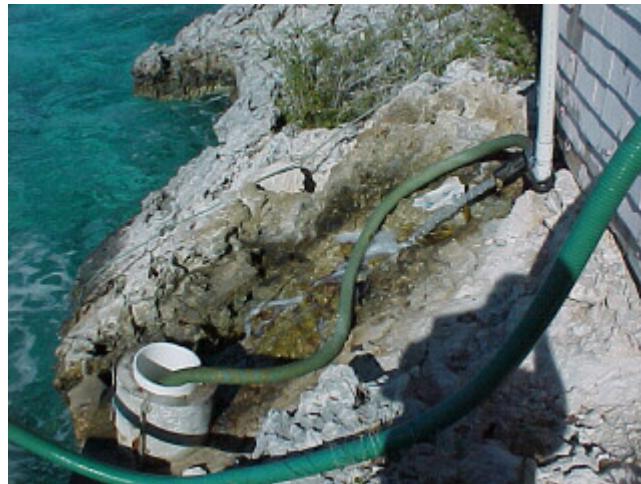
A 7.5 hp motor circulates sea water through the system constantly, but is not currently in use. The approximate load on the system is large. With typical motor/drive efficiency, a 7.5 hp pump will draw about 12 kW. Thus, this pump (Figure 5) is about 25% of the base load electricity use on the island and represents about 20 amps of load at 480 Volts. Its constant operation is also unneeded at the present time.

Figure 5. Sea water pump.

Recommendation: The sea water circulation pump should only be powered during evening hours (midnight until 4 AM) to prevent buildup of barnacles and other biota that may foul the system. This will avoid the daytime peak demand. A simple timer can be used. If no further use of the facility is planned, the operation of this pump should be discontinued as it represents a large load.

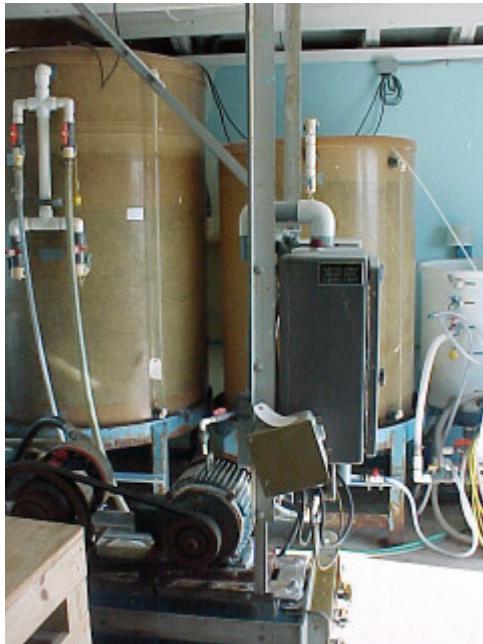
Power for operation of the reverse osmosis (RO) system (Figure 6) consists of the necessary pumps for the desalination system. This consists of a 10 hp, 1000 psi diaphragm pump; a 1 hp salt water pump to bring salt water up to the facility and a 3 hp boost pump to maintain pressure within the RO system.

Figure 6. The reverse osmosis system.

Recommendation: Operation of the RO facility is vital as it provides fresh water for the island. However, the 3 hp boost pump is considerably over-sized. When in need of replacement, a 3/4 hp boost pump should be substituted. Also, the cistern system on the island should be expanded with connection of all existing cisterns to water supply to take advantage of their water collection. Where cisterns are not used, inexpensive "rain barrel" systems should be considered. With the replacement of current roofs with white metal roofs, the run off should be connected to cisterns or rain barrels. Rain barrel water can be used for various gardening and other non-potable needs.

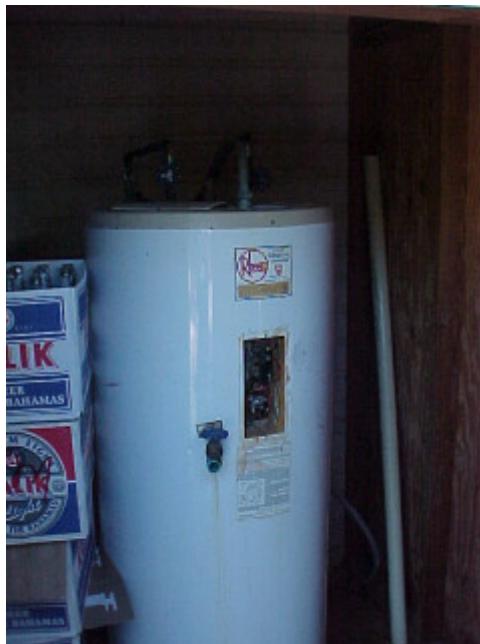
The kitchen is served by an 80 gallon tank (81VR-80-1 solar ready) with two 4500 W elements (Figure 7). The thermostat is set to 140°F. Each system draws 9 amps at 480 volts when the elements of a water heater are activated.

Figure 7. Solar ready kitchen hot water heater (80 gallon).

Recommendation: All the water heating on the island should be revamped over time as the systems need repair or replacement. They should be changed to a two tank solar water heating system with a primary solar tank (40 gallon) with an elevated auxiliary tank with only the upper elements powered. There are currently a dozen 4 x 10 ft solar collectors (Solar Development Inc., SDC8W) in storage on the island, still located in their original shipping container and un-utilized (Figure 9). Use of solar water heating could virtually eliminate this load on the island.

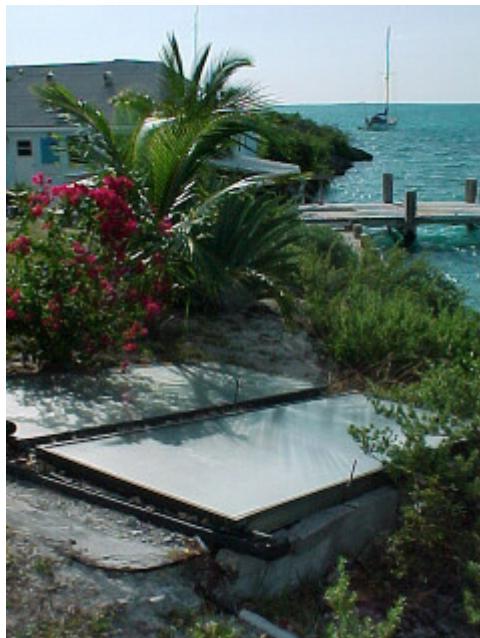
Potential for substitution of solar water heating is very high. A listing of the water heaters on the island was prepared by Jim Tryzbiak (Table 3). Nine of the units are electric resistance, while only a single unit is solar. Several solar systems, although operating, are not connected (Figure 8).

Figure 8. Unconnected solar water heating system.

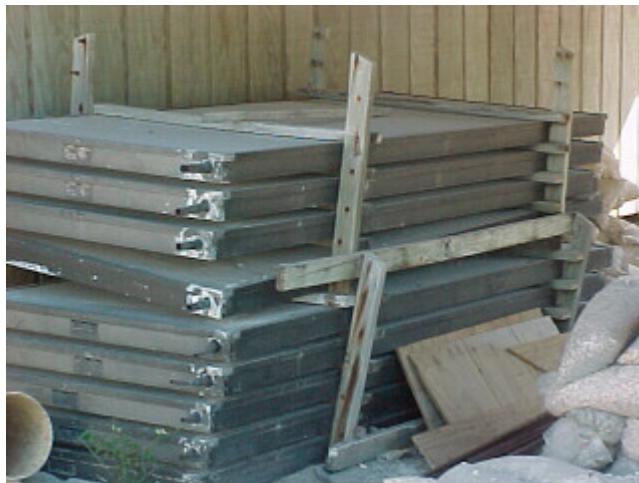
Figure 9. Unopened solar collectors for water heating still in shipping crate.

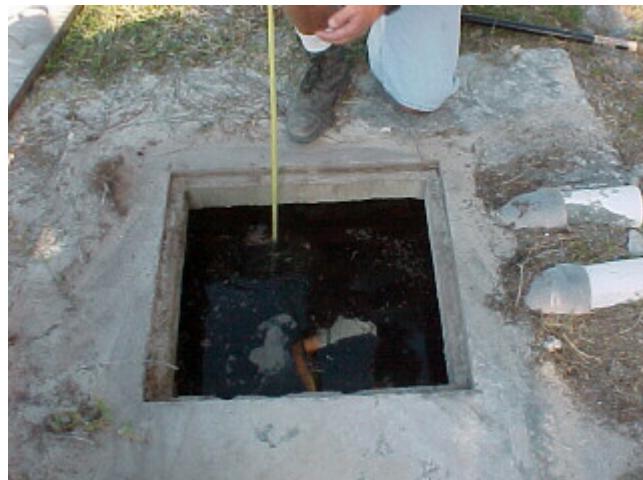
Many of the older buildings have cisterns; for instance the older Perry house and another located just south of the commissary. The commissary cistern (Figure 11) is fed by PVC piping from the Commissary apartment roof, the VIP quarters and from the Kitchen/Lounge. The cistern under the commissary is not currently utilized! The cistern measures 48 x 128 with the water up to a 54" depth. Each cubic foot of water stored is approximately 7.5 gallons, so that the cistern currently holds 193 ft³ of water or roughly 1,450 gallons which is not currently used.

Figure 11. Cistern at the commissary.

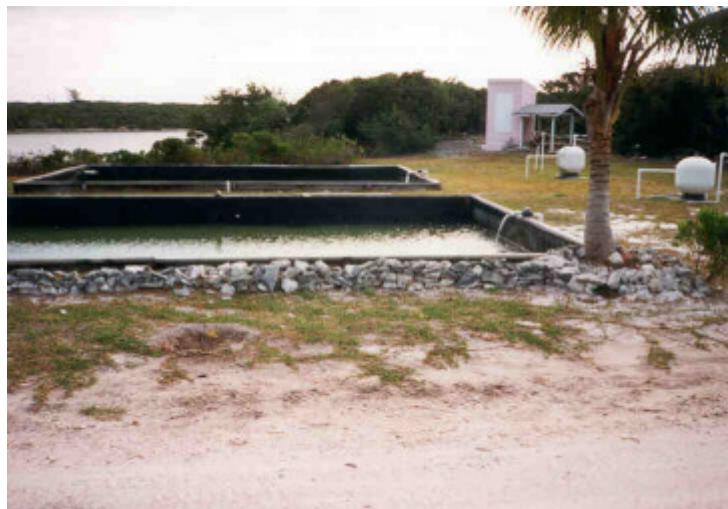
The fish hatchery raised Tilapia sp. from eggs and provided fish to fish farms. The facility functioned for a five year period. It operated under previous contracts which have expired. The hatchery was shut down in 1995 and has been abandoned since (Figure 13).

Figure 13. Pumping of an unused aquaculture facilities.

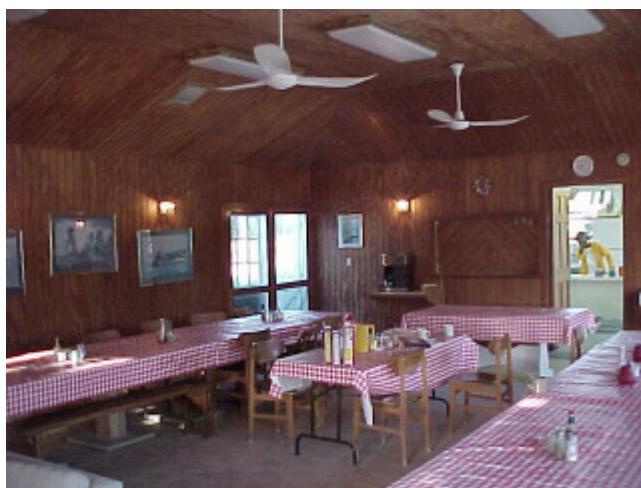
The kitchen and dining areas are unconditioned. Ceiling and wall-mounted fans are provided to aid occupant comfort. The dining area has a large roof section facing south. The dining area has six 40 W lamps on a dimmer that are frequently left on. The kitchen area is a source of comfort complaints; it is too warm. At 1:40 PM on February 17, 1999, the measured temperatures with no cooking were:

Figure 14. Southwest corner of the dining area.

Recommendation: A well ventilated outside room should be added on the north side of the kitchen with swing doors that contain the refrigerators separate from the kitchen area. A vented range hood should be provided over the cooking area. This is an important fire safety feature and will also significantly reduce heat build-up in the kitchen. When new refrigerators are purchased for the island, the most efficient units of the size and type required should be specified.[\(5\)](#)

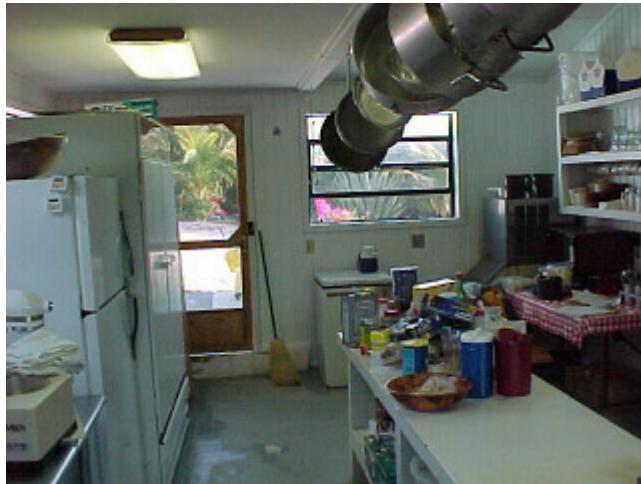
A primary reason for heat build up is the refrigeration loads in the kitchen area (Figure 15). The refrigerators on the island vary greatly in age and efficiency. Some are much newer (in the apartments), while others are old (kitchen and

lounge). The soda and beer refrigerators in the Lounge are aging and likely inefficient. The refrigerators in both the kitchen and the lounge increase the energy load, and the ones in the kitchen dump large amounts of heat into that area, increasing discomfort:

Figure 15. Interior of kitchen facilities

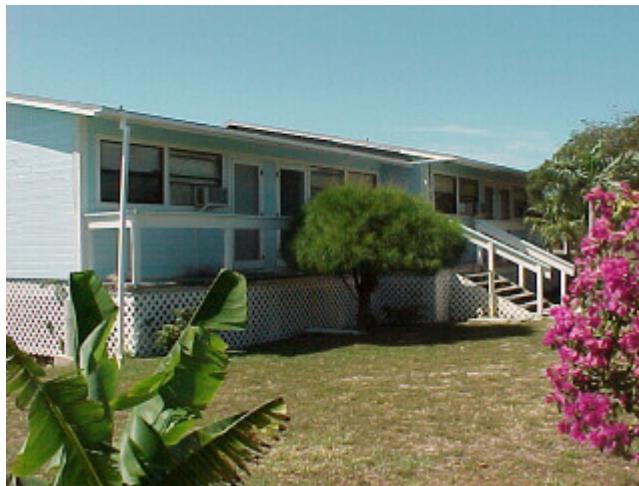
There are four units in the facility with double bunk beds (Figure 16). The attic area above has roughly R-11 insulation installed. A sliding glass door in each unit faces south towards the ocean. There is no overhang and this produces major sensible heat gain in the rooms. Each room has a small window air conditioner and several incandescent lights (typically 60 W).

Figure 16. VIP quarters.

Recommendation: A large porch/overhang is to be constructed on the south side of the scientists' quarters to keep solar radiation off the large glazed areas and walls. The room AC units will be placed on a door/occupancy sensor system so that the units are deactivated when no one is in the room for more than thirty minutes. Compact fluorescent lighting is to be installed in lamps and the bathrooms of the quarters to learn how well they might work to reduce lighting electrical loads.

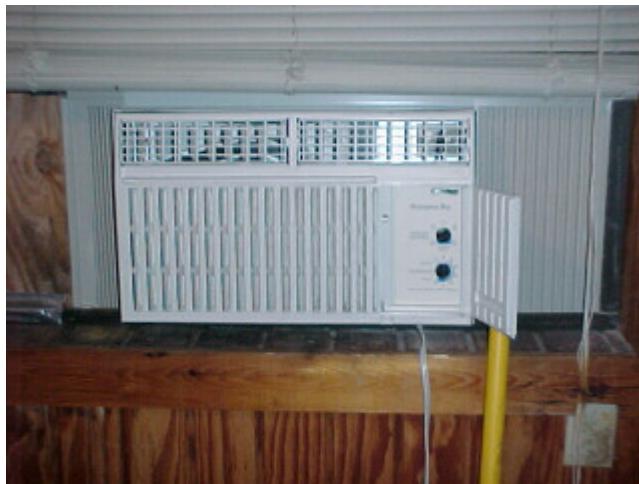
Constant operation of air conditioners (AC) year round contribute to the electrical load on the island. All AC units (except lab and climate control lab) are window or wall units (Figure 17). The lack of distribution losses make window units more efficient. Also, replacement is relatively cheap and repair is not as complex and can be accomplished by island occupants. The replacement rate is about 10 per year (which means that the AC mean time to failure is approximately 3.0 years). Corrosion is a major problem and periodic flushing of AC condenser coils every other month may improve longevity.

Figure 17. Typical room air conditioner.

Primary mode of operation is to operate the units continuously at low speed. The facilities manager has been told to leave units on continuously since turning them off makes them fail prematurely. However, communication with the Carrier Corporation (Carrier Corp., 1999), who manufactures air conditioners suggests that this is not the case and that periodic flushing of the condenser surfaces with fresh water every other month should be much more important to unit longevity in the Bahamas than turning units on and off.[\(6\)](#) Corrosion is a severe problem with respect to the AC units. Their typical longevity is less than five years. A listing of the AC units and their disposition is given in Table 5 below:

Recommendations: Turning off units when buildings are unoccupied will not only reduce load, but may extend the life of the units. For the new chemistry lab building, wall and window units should be installed. Central systems should be avoided due to difficulties with repair. Try and buy efficient units where affordable. Units in the office and anywhere else that there is electronic equipment should be left on not only to keep the rooms cool but also to control humidity to prevent degradation of the electronics and books present there. The same is not true in living quarters, however. These units should be turned off when units are vacant. It would be useful to track the installation and failure times of existing units that are installed.

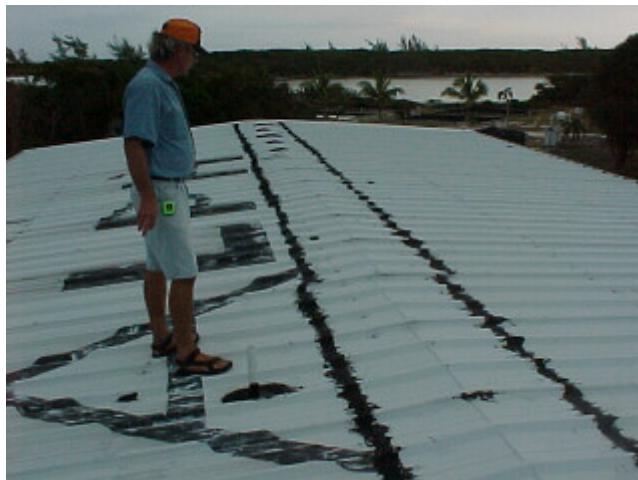
The current lab is a Butler type metal building with a metal roof manufactured by Gulf State. The age of the building is approximately 8 - 10 years. There is concern about the rate of corrosion at this facility. There has also been a frequent leaking of the roof and problems with the air handlers located above the acoustic tile ceiling. Examination of the roof of the lab building shows that the problem is due to the 1/12 roof pitch of the metal roof. The low pitch allows blowing rain to force moisture in around the roof cap. This problem can be avoided with metal roofs in future projects by requiring at least a 3/12 roof pitch for their use.

Figure 18. Facilities manager Jim Tryzbiak inspects the roof of the lab building.

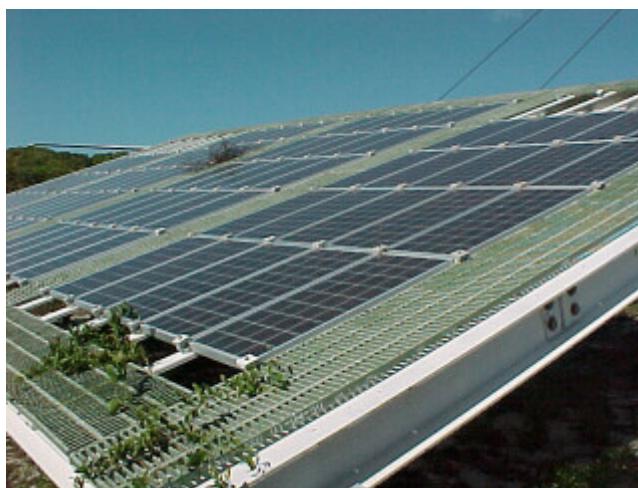
The hill top photovoltaic (PV) system is abandoned (Figure 19). It consists of ninety 50-Watt BP PV modules (BP 104346) in a single large south facing array. Each module measures 37.5 x 17 inches. Twelve additional PV modules of the same type are in storage. The operating modules appear to be in good condition and are generating close to their specified output. Their total output is approximately 4.5 kW (DC). These could easily be tied into an inverter which feeds directly into the island power grid to supplement the diesel generator. During daytime hours they could carry between 10 and 15% of the total electrical load of the island. They would produce about 9,000 kWh per year for a savings in diesel fuel of about 1,000 gallons, worth about \$1,000 per year at current prices.

Figure 19. Unused hill top photovoltaic system.

Recommendation: The current PV panels are charging fouled batteries and doing nothing otherwise. They should be wired into the power grid as soon as possible. This would help reduce loads immediately. It is also recommended that PV be considered as a viable power source for future facilities. While it will not meet all the needs of the island, it can considerably reduce diesel fuel usage and therefore consumption. All new buildings or reconstructed facilities should have

even 2 kW of PV so as to be self sufficient. It is recommended that 2 kW PV be attached to the new chemistry lab building as a first step.

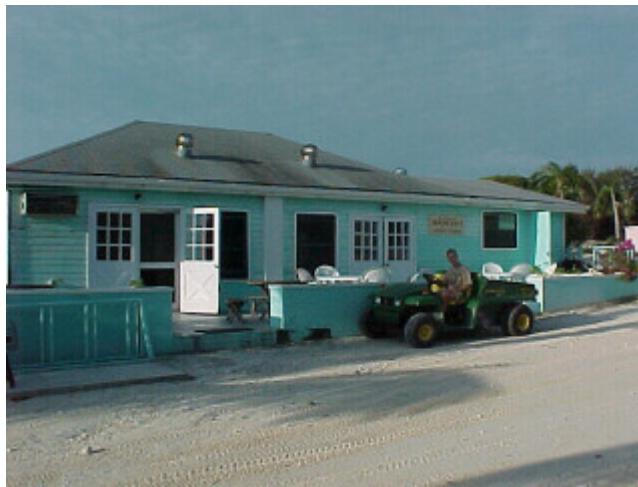
Most of the buildings' roofs have light gray asphalt shingles over plywood decking (Figure 20). The majority of the roofs are A-frame except the lab building, VIP building, and some assorted to storage buildings. Some roofs are in very good condition, while others are in disrepair. Shingle roofs will last less than 15 years in a tropical environment.

Figure 20. Shingle roof of the kitchen/lounge.

Termites are a significant problem for non-treated wood of any kind on the island and even plywood over treated wood trusses. Metal or concrete roofs are an advantage for the buildings since they can readily be purchased white (reduces cooling), have good longevity and also work well to maintain clean cisterns.

Recommendations: Any time that a roof needs to be replaced it should be replaced by a white metal roof where possible. (Z) The roof should be installed properly with all ridge caps and sealants. The roofs of new buildings should be concrete where possible.

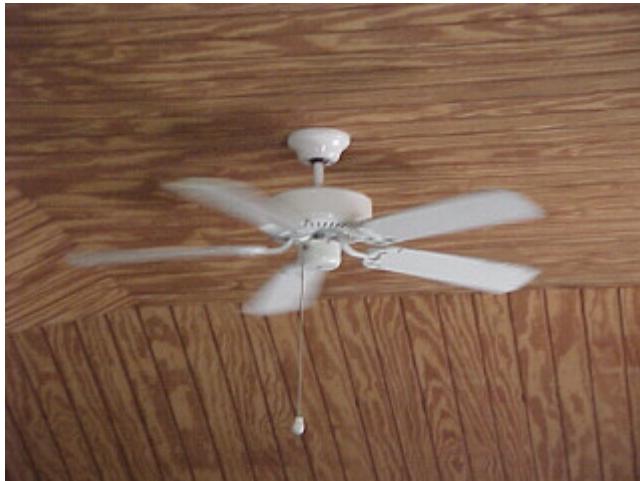
Ceiling fans are often left on, typically drawing about 30 watts at medium speed. Better operational control of fans could easily reduce the average island power draw by about 500 watts (1 amp @480 Volts).

Figure 22. Typical ceiling fan in apartments on LSI. They are generally always on.

Recommendations: When rooms are unoccupied the ceiling fans should be turned off. They provide no comfort when no one is there and, in fact, add heat to the space. An improved ceiling fan design may soon be available that can increase air circulation with less energy expenditure. Larger 64" fans should replace the three bladed fans in the lounge area (Figure 23).

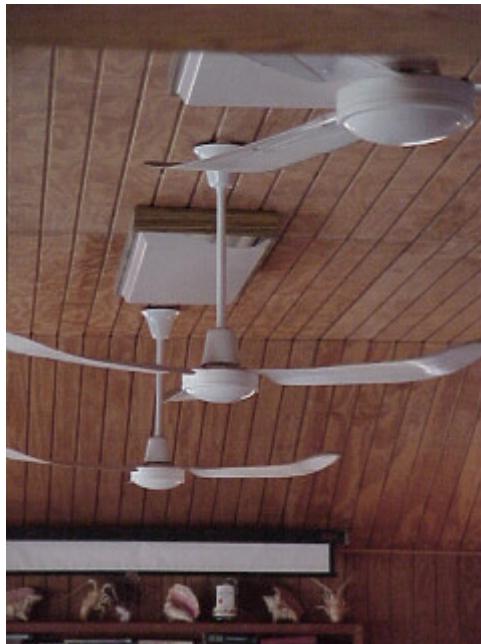
Figure 23. Large ceiling fans located in the lounge.

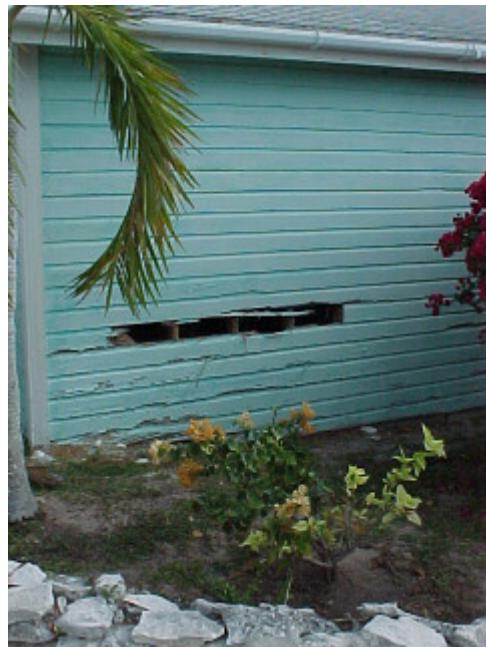
Termites are a very serious problem on the island (Figures 24 and 25). The salt water environment also creates a very corrosive circumstance for metals (Figures 26 and 27). Evidence of termite activity is evident in nearly all buildings. The current method of continual spraying and treatment is both expensive, labor intensive and unhealthy. A much better solution is to use termite resistant construction techniques for all future construction.

Figure 24. Problems with termites.

Recommendation: Use all concrete construction in future facilities to avoid both problems with termites and corrosion (metal).

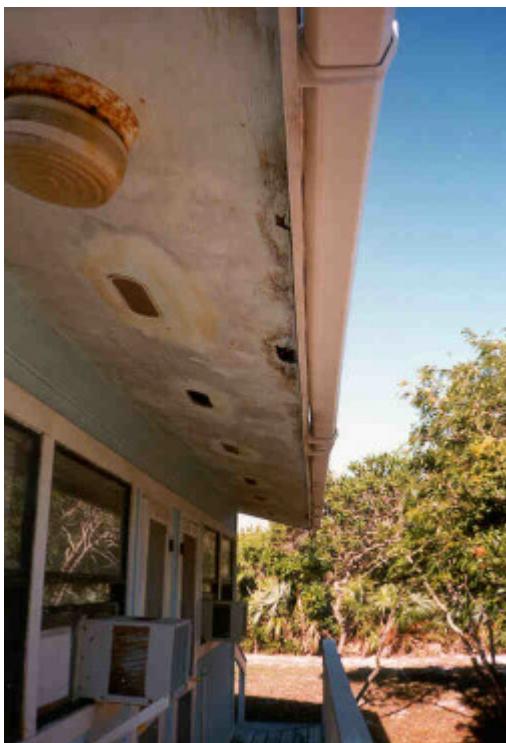
Figure 25. Corrosion and termite damage.

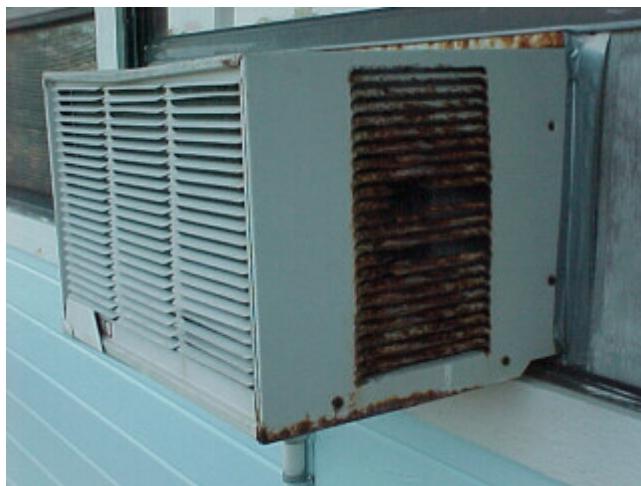
Figure 26. Corroded air conditioner.

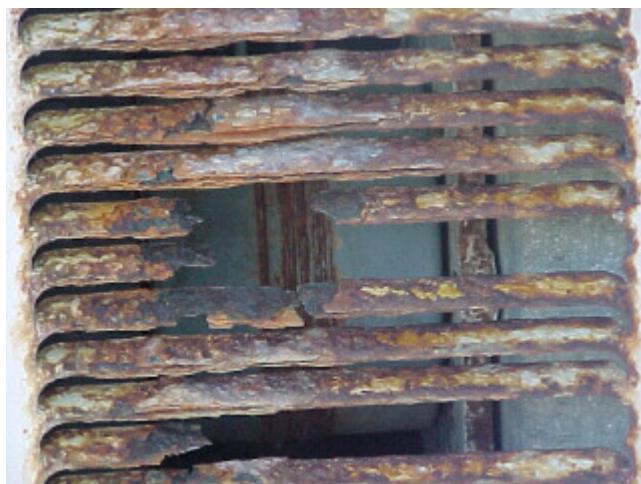
Figure 27. Close-up of corrosion on condenser inlet.

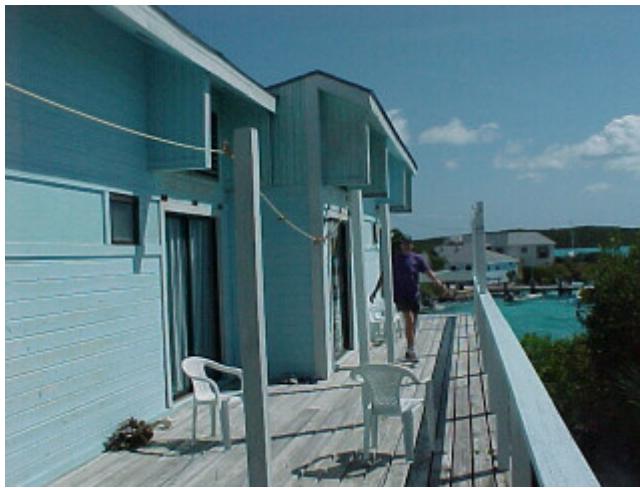
Figure 29. South-facing deck of the VIP showing the exposure of the walls and windows to afternoon sunlight. Will be retrofit with an eight-foot porch.

Retrofits will be implemented after a base-line monitoring period. All the VIP quarters will include compact fluorescent lighting (CFL's) in place of the current incandescent and halogen light bulbs. The window air conditioners will be replaced by more efficient units and a white metal roof will be attached to the existing roof. An 8 foot porch will be added to the south ocean-facing exterior of the quarters to shade the sliding glass doors.
