# **HOLIDAY SHORES STORMWATER RETROFITTING PROJECT**

DEP AGREEMENT S0098 FINAL REPORT – JANUARY 2009

CONTRACTOR:  
WALTON COUNTY PUBLIC WORKS DEPARTMENT

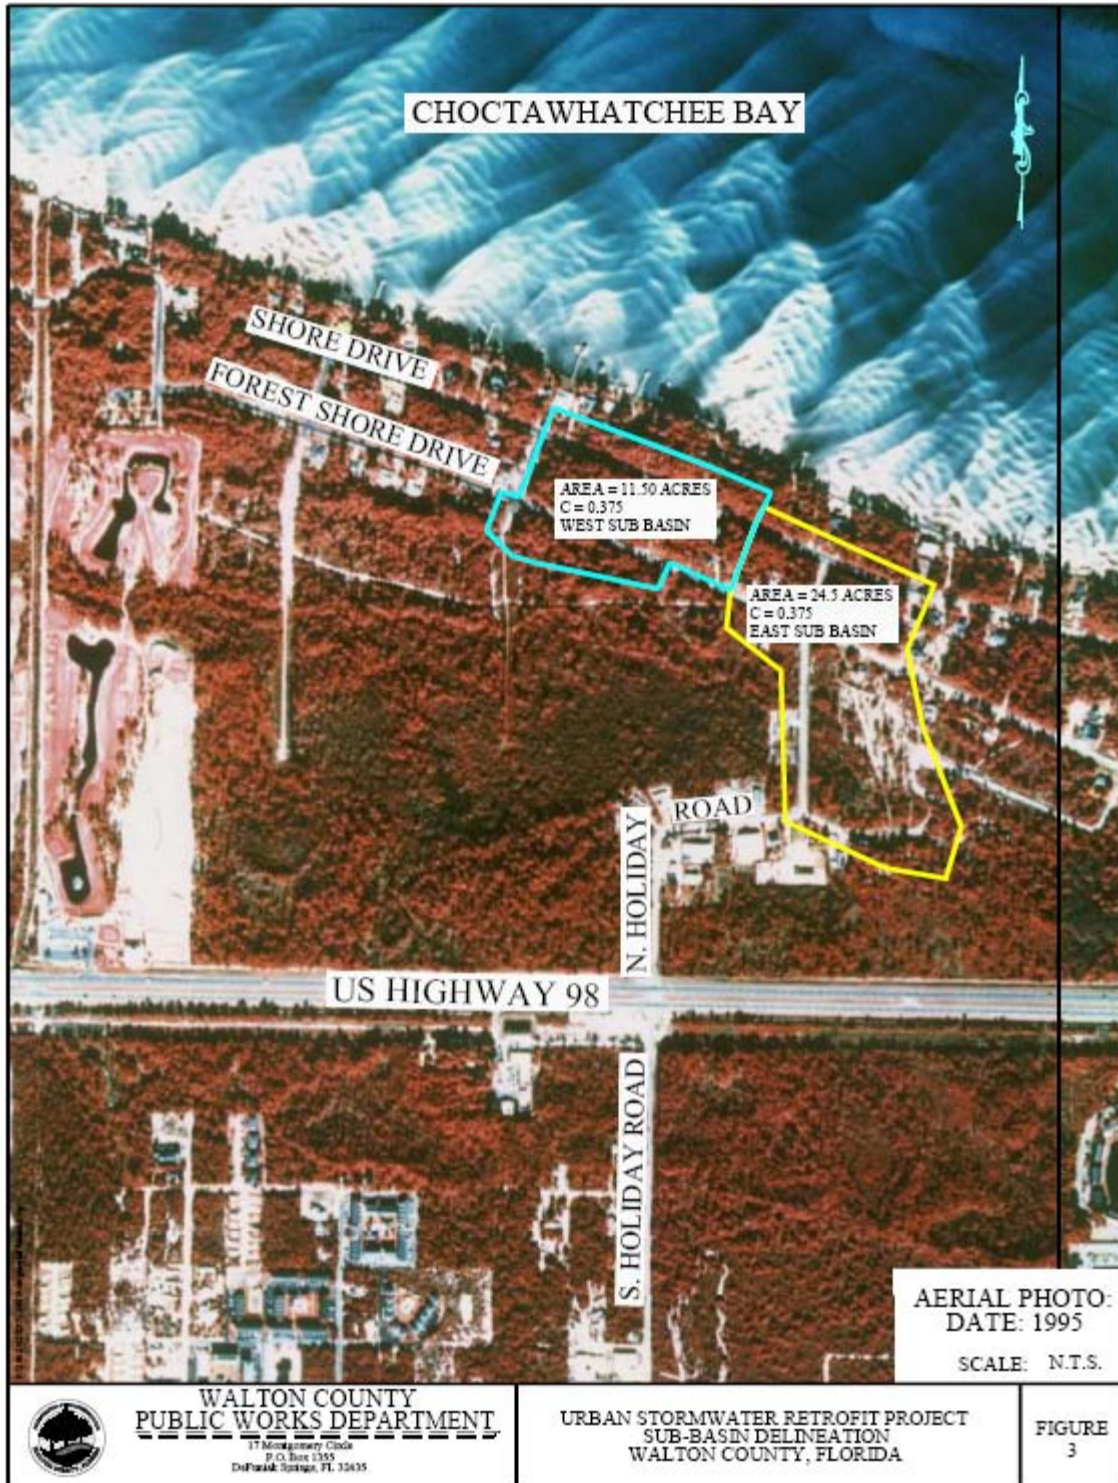
FIGURE 3a

This project sub-divided the drainage basin into two separate areas noted as West Sub-basin and East Sub-basin (see Figure 3a). In each sub-basin, the existing secondary conveyance ditches were reshaped to the maximum extent practical given right-of-way

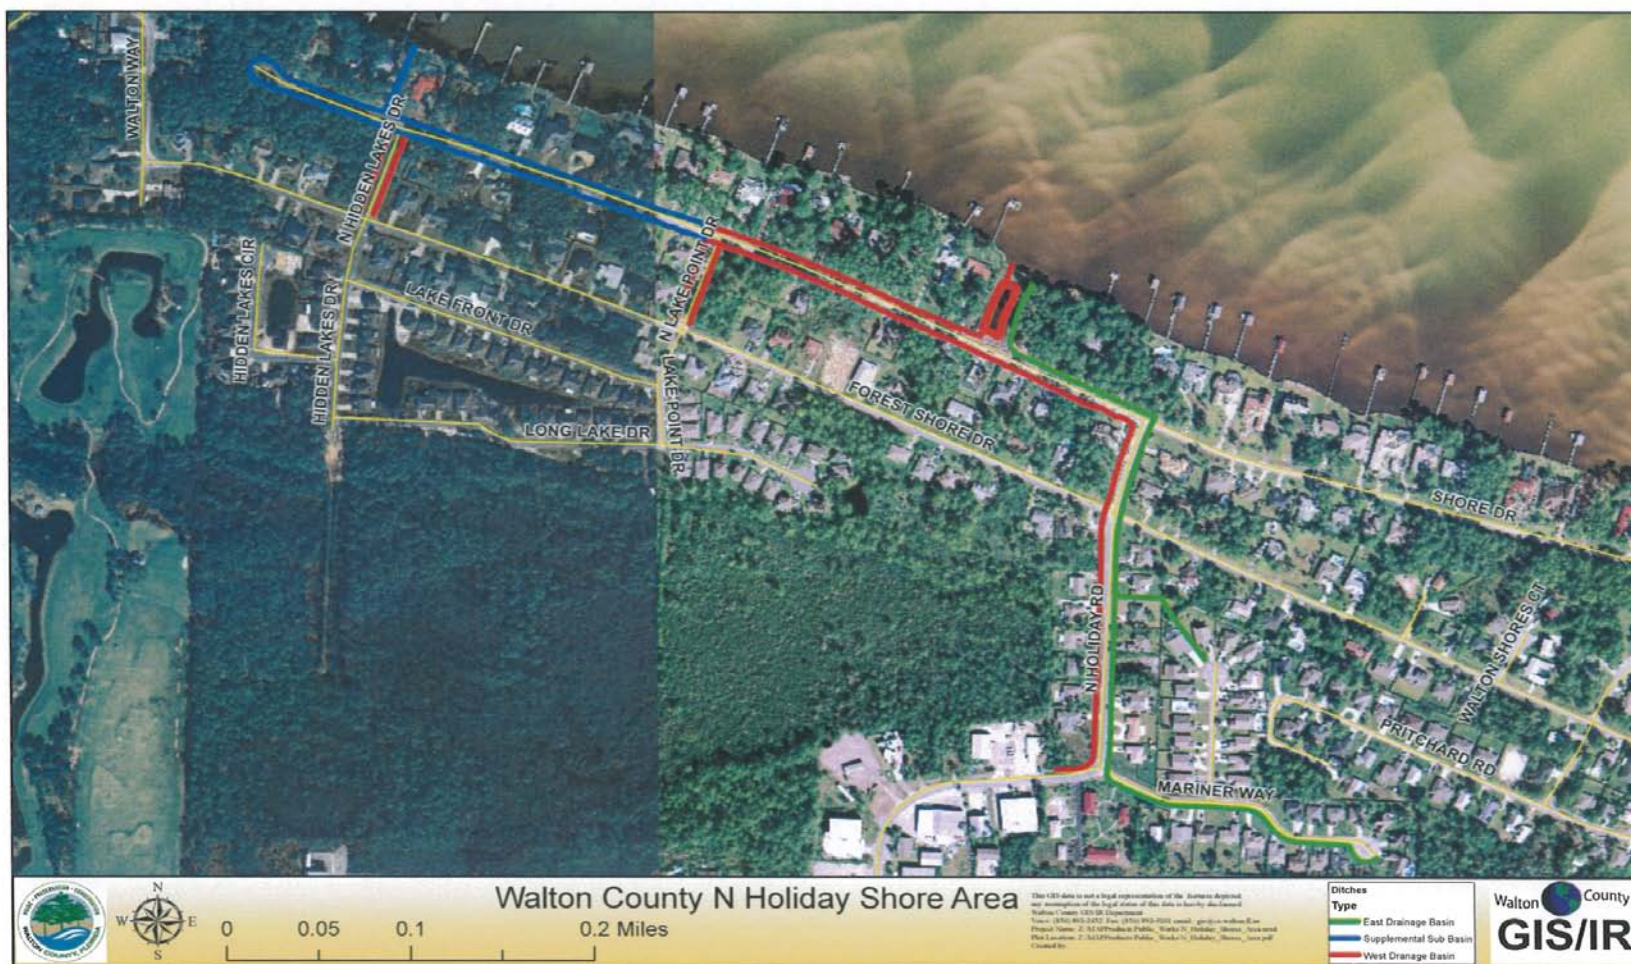
FIGURE 3b

The West Sub-basin (11.5 acres) had approximately 3,580 LF of reconstructed ditches (shown in red on Figure 3b) directed to a new wet detention treatment pond with an outfall to the existing primary discharge ditch. The Wet Detention Pond was sized to treat 0.5-inch of runoff and bypass larger storm events to the primary swale through Haugen Park. The pond is approximately 65 feet wide by 180 feet long. It is constructed with as large as possible permanent pool that is 6 – 8 feet deep blending into a littoral shelf planted with wetland species at the outfall that is about 2 feet deep. The littoral shelf occupies 25 – 30 % of the pond area. The treatment volume is approximately 20,260 cubic feet. Pollutants are removed through settling, biological activity in the permanent pool, vegetative uptake of nutrients and retention in the soil of the pond.

For the East Sub-basin (24.5 acres) approximately 2,155 LF of ditch was reconstructed plus 1,239 LF of new hard pipe installed (shown in green on Figure 3b) to allow for shallower side slopes and positive flow into a Second Generation Baffle Box. The Second Generation Baffle Box retains pollutants by first diverting flow and associated solids and pollutants in stormwater runoff over a Nutrient/Vegetation/Litter Separation screen into three concrete sediment chambers. The box's dimensions are 14' long X 8' wide X 8' tall with 48" weirs. The screen separates the foliage from the water preventing nutrient loss to the water flow while heavier sediment gets separated out and falls to the bottom of the chambers. The structure is sized to accept flow from the 24.5 acres (East Sub-basin) at a rate of approximately 11 cubic feet per second (cfs) which equates to the first ½-inch of runoff for the East Sub-basin. The Second Generation Baffle Box is equipped to bypass storm events producing greater than a ½-inch of runoff without blocking flow.

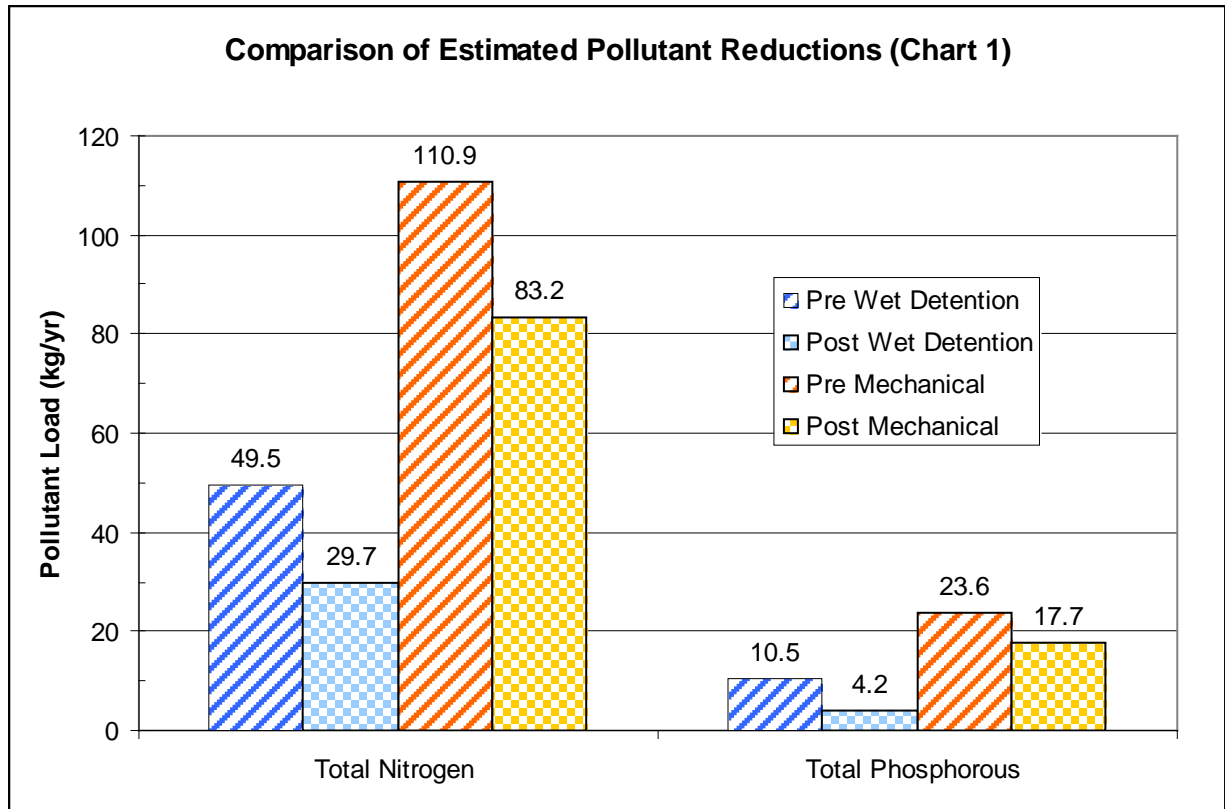
**Figure 5**

Figures 5 and 6 compare the estimated pre and post pollutant levels in both the wet detention pond and the second generation baffle box.

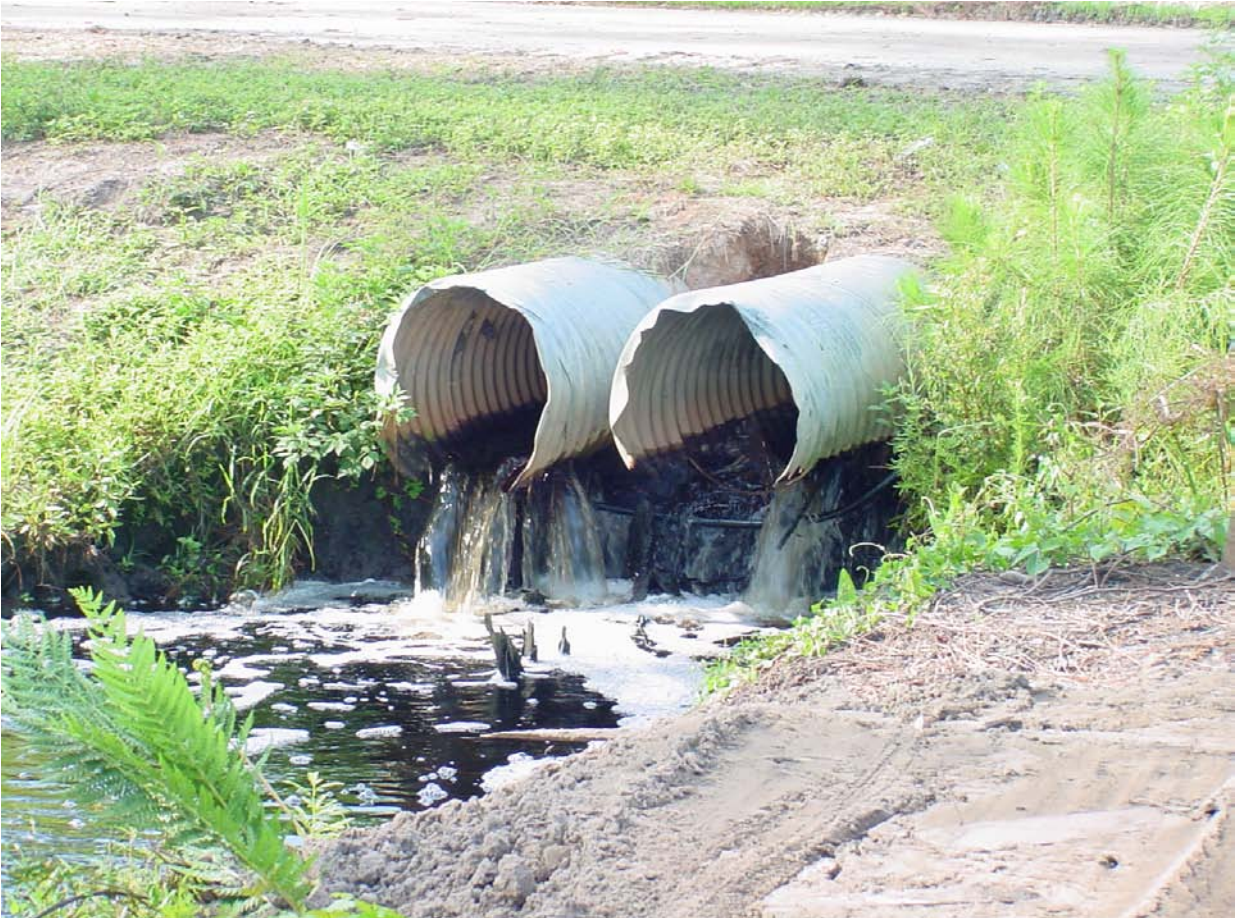
This was the original untreated discharge under Shore Drive from sub-basins 1 and 2 to the swale in Haugen Park before the flow was divided and routed to two treatment alternatives. This runoff ran about 135 feet through the Park to Choctawhatchee Bay. Treatment is now provided at the Park site for almost 35 acres of contributing watershed area by a wet detention pond and a baffle box.

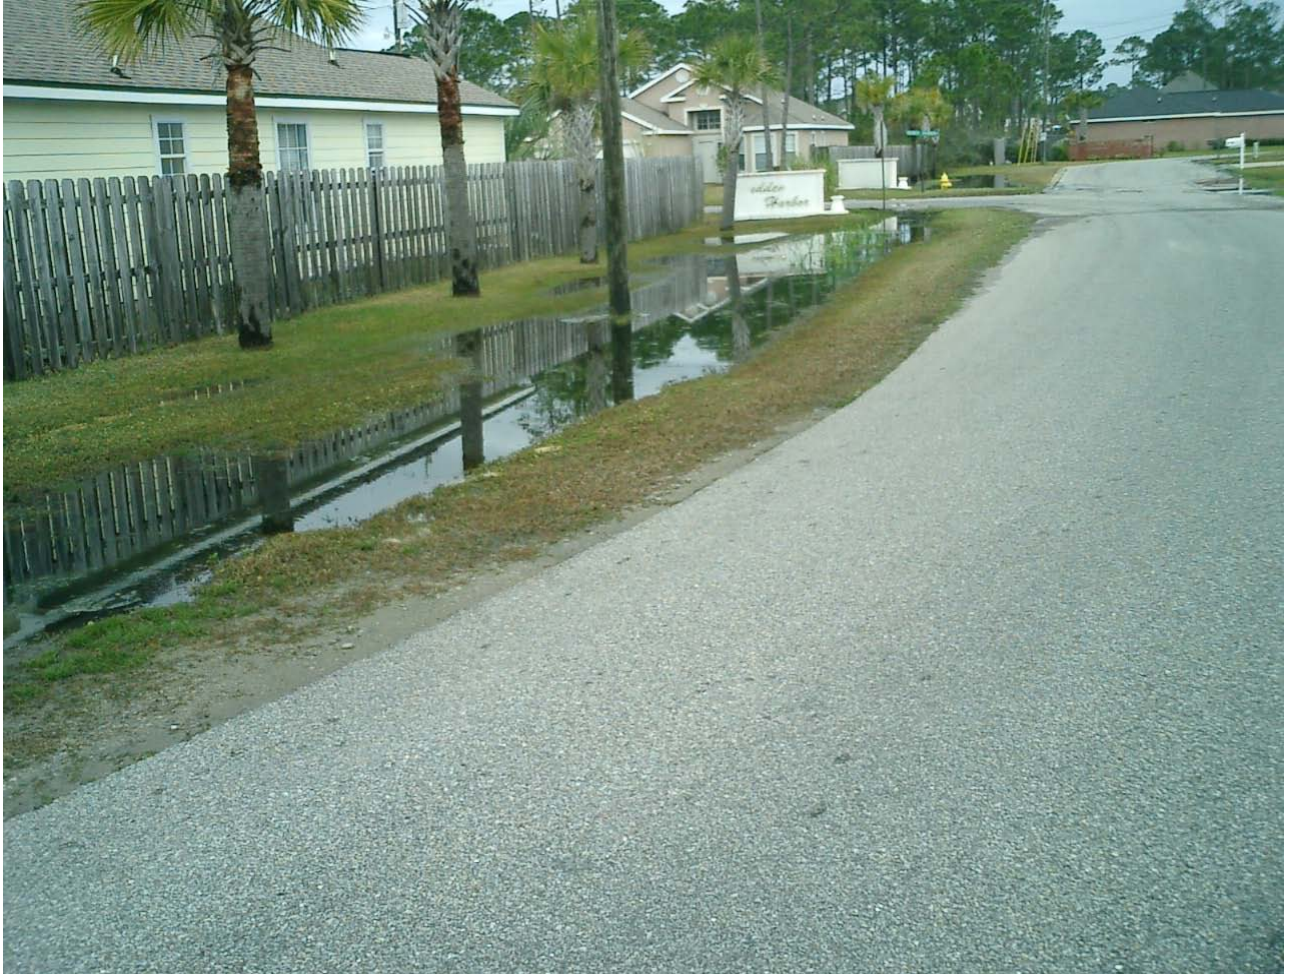
This is the north side of Mariner Way at the entrance to the Hidden Harbor Estates subdivision after a routine storm event. This subdivision is the origin for much of the runoff that is now diverted to a second generation nutrient removing Baffle Box that was installed in Haugen Park. The rest originates from yards and side streets along the east side of Holiday Road and Malibu Gardens to the south. This watershed is sub-basin 1. It is the largest of the three contributing watersheds that were a part of the Holiday Shores project.

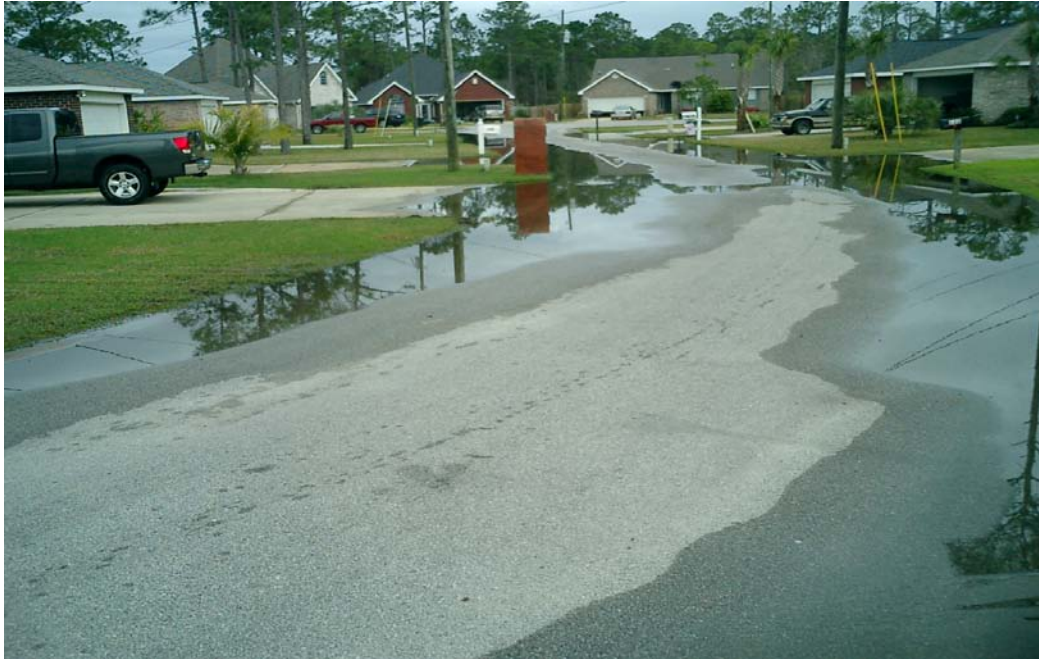
This is further east on Mariner Way in sub-basin 1 looking towards the cul-de-sac at the rear of the Hidden Harbor Estates subdivision.

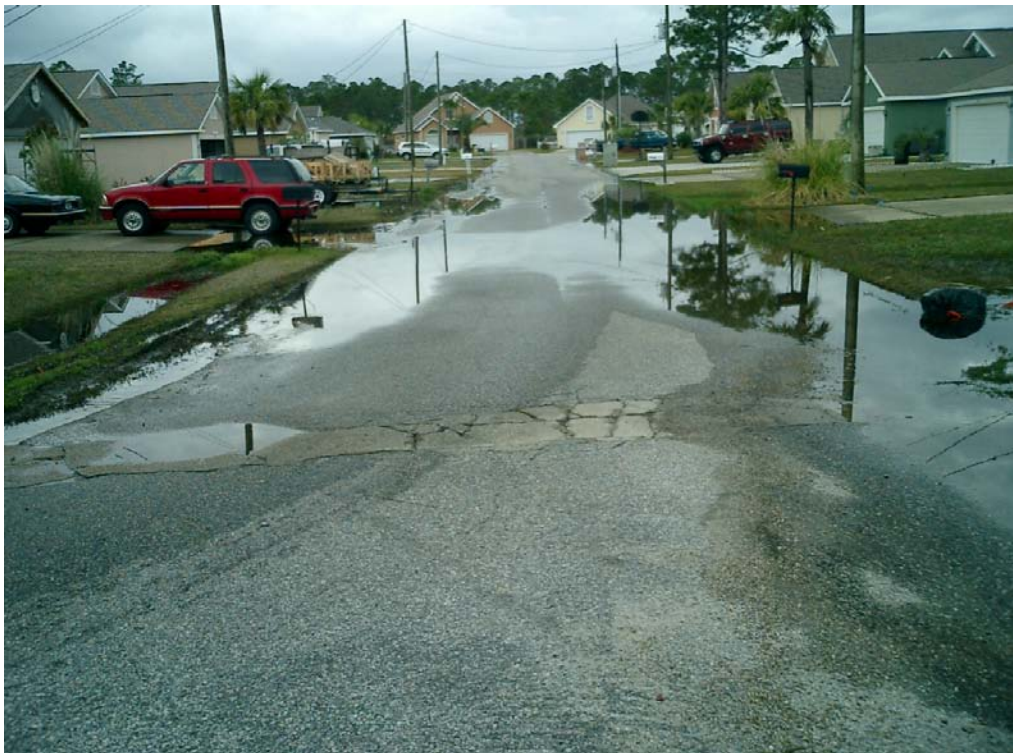
This is Hidden Harbor Lane in sub-basin 1 looking north towards the cul-de-sac at the end of the street. There was no outlet for the runoff that accumulated on this street.

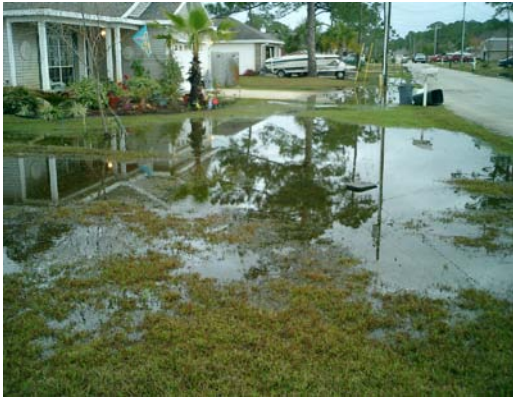
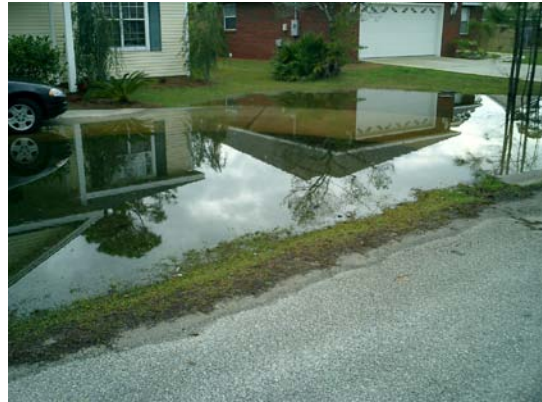
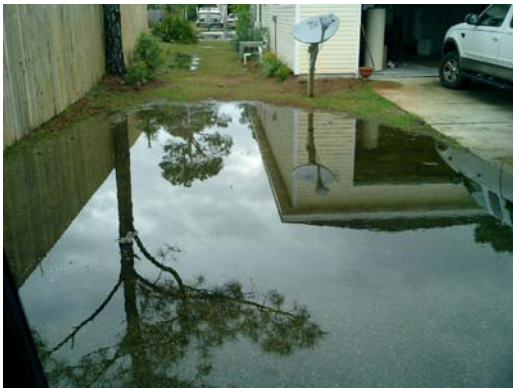
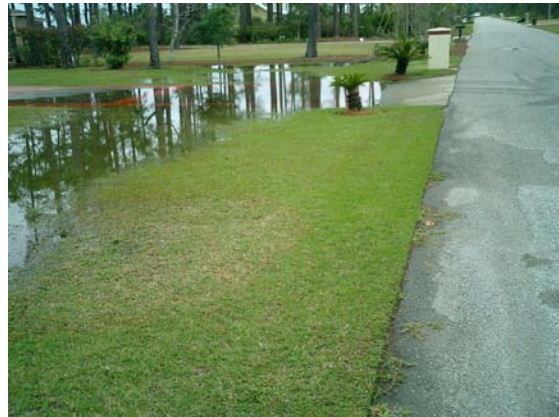
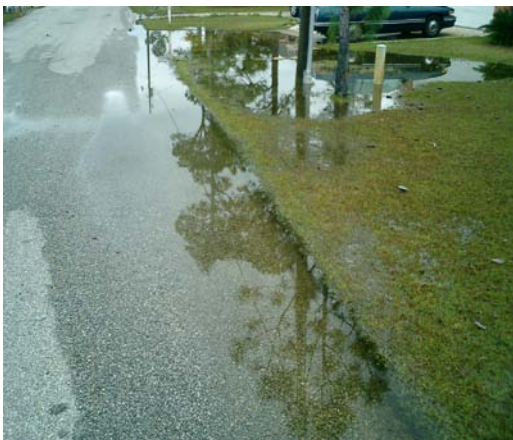
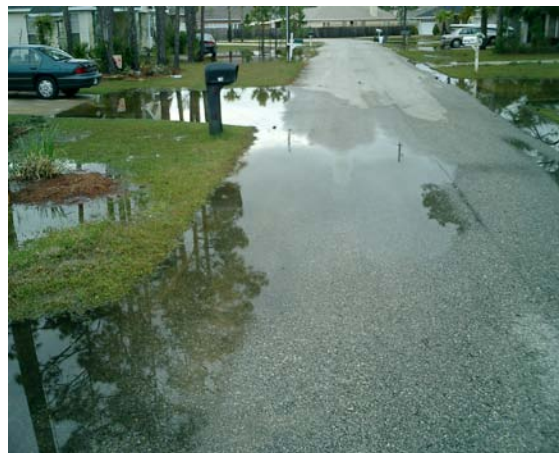
This is a selection of typical preconstruction photos showing widespread flooding throughout the Holiday Shores project. In addition to resolving flooding and standing water concerns the BMPs also provided water quality benefits by treating the runoff prior to discharge to Choctawhatchee Bay

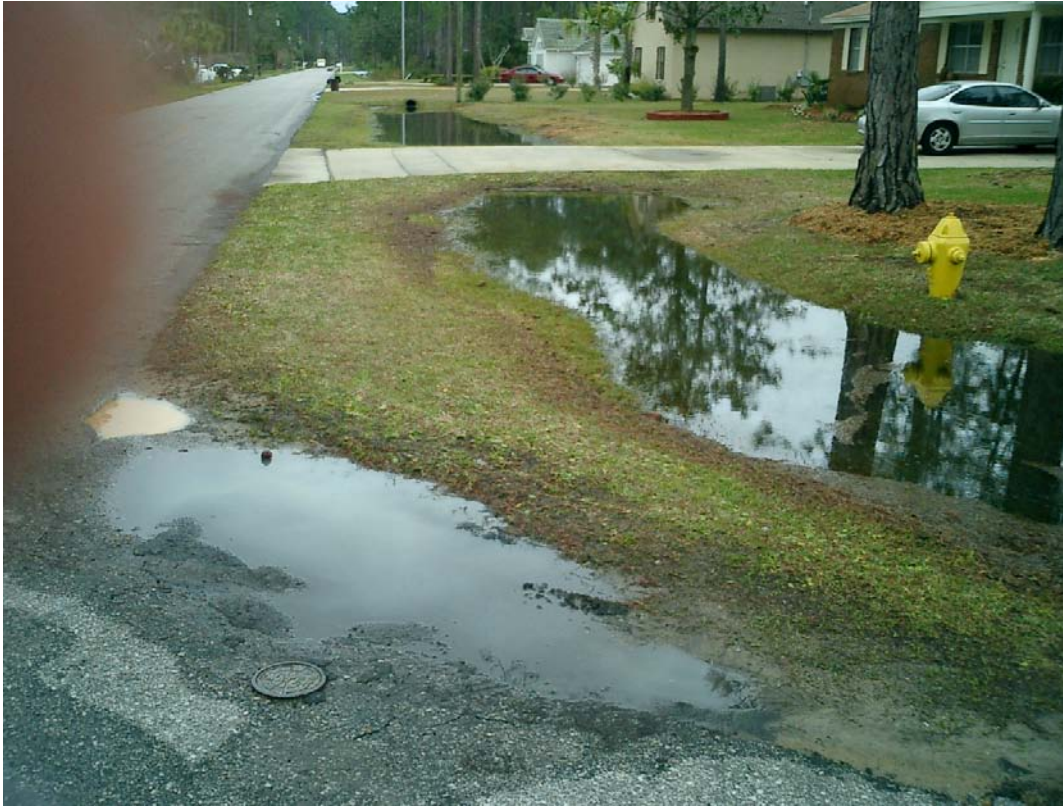
This is the corner of Mariner way and North Holiday Road in sub-basin 1 looking south towards Choctawhatchee Bay. Undersized culverts and mismatched invert elevations were contributing to flooding problems and long periods of standing water. The lack of positive drainage prevented the system from recovering its capacity between storms. Several rainy days in quick succession was causing extreme problems for upstream residents.

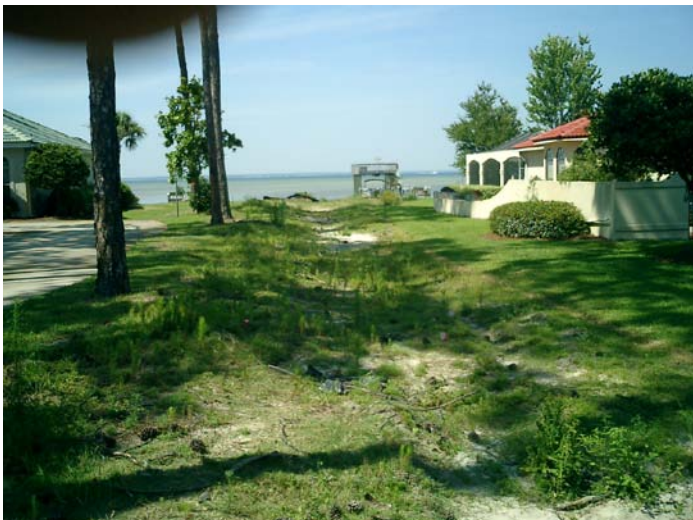
There was very little runoff discharged through this unimproved easement in sub-basin 3 before wide spread flooding of nearby residential properties occurred. In between storm events, there were long periods of standing water in sub-basin 3 because there was not a functional outfall.

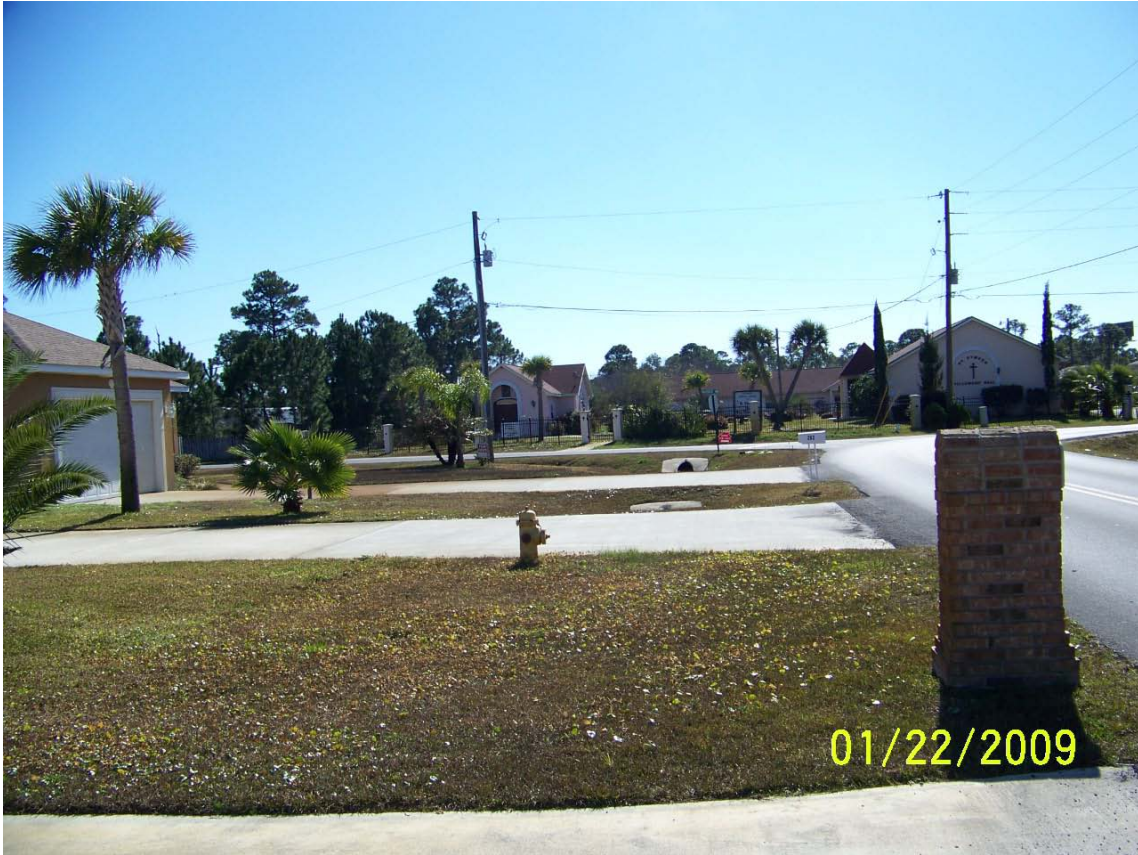
This is the corner of Mariner Way and North Holiday Road looking south or upstream towards Hidden Harbor Estates. The large swale at the entrance of the subdivision merges from the left with the hard pipe from the uppermost and south sections of the watershed at the mitered end which is visible top center in the photo. Several driveways were hard-piped as a single unit at this particular location due to underground utilities that needed to remain buried. From here to the inlet of the baffle box in Haugen Park swales provide conveyance and the culverts normally occur underneath individual driveways.

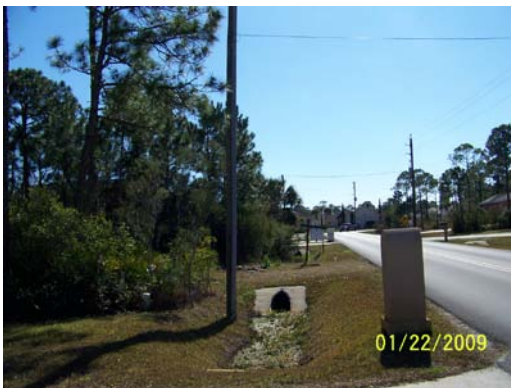
Typical swale along N. Holiday Road.

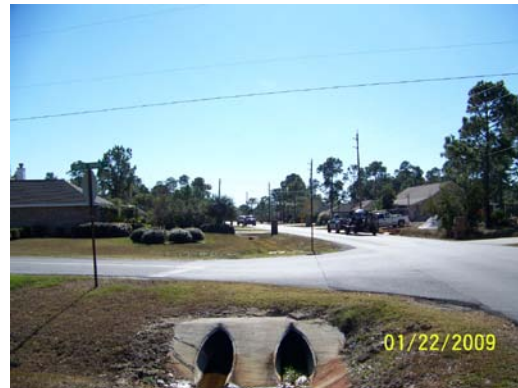
Twin 24" pipes under Forest Shore Dr.

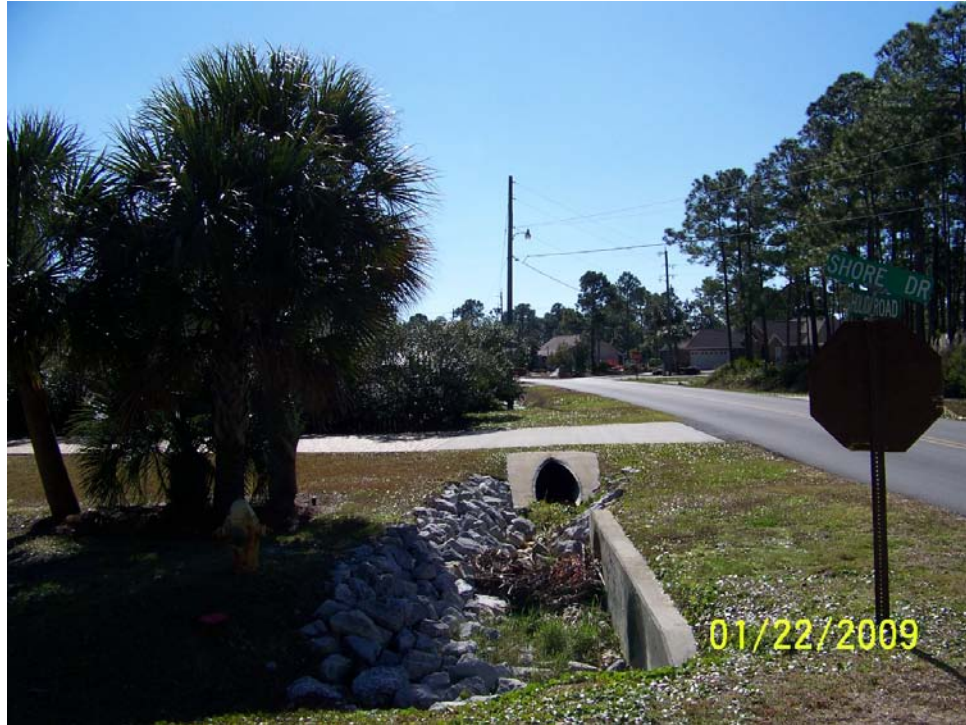
This is the corner of North Holiday Road and Shore Drive where the upstream flow from sub-basin 1 is brought underneath Shore Drive.

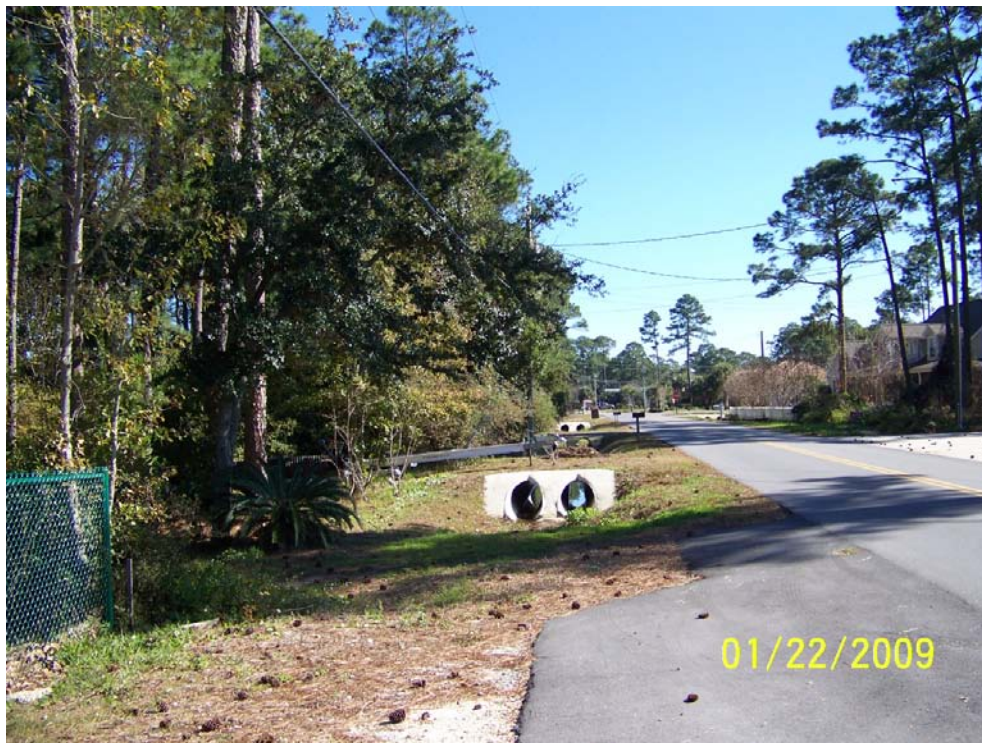
Culverts throughout sub-basins 1 and 2 range from 18 inches at the top of the sub-basins to 24, twin 24s, then 30 and finally twin 30s.

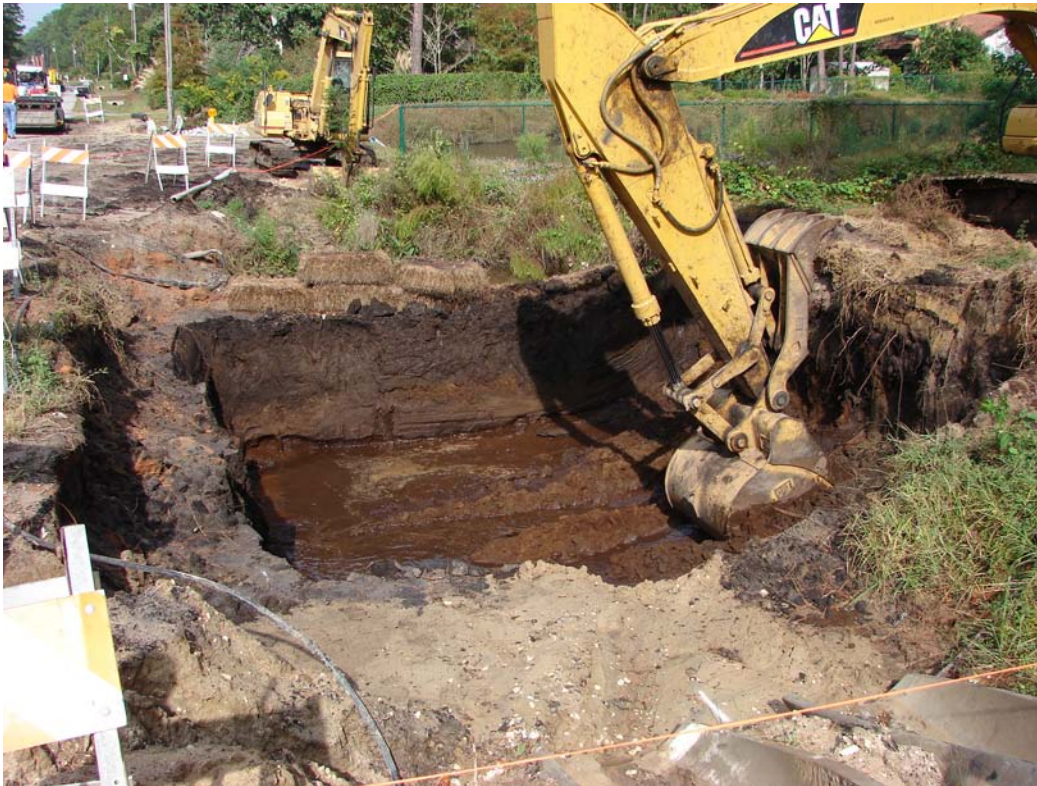
Excavation for baffle box to be installed.

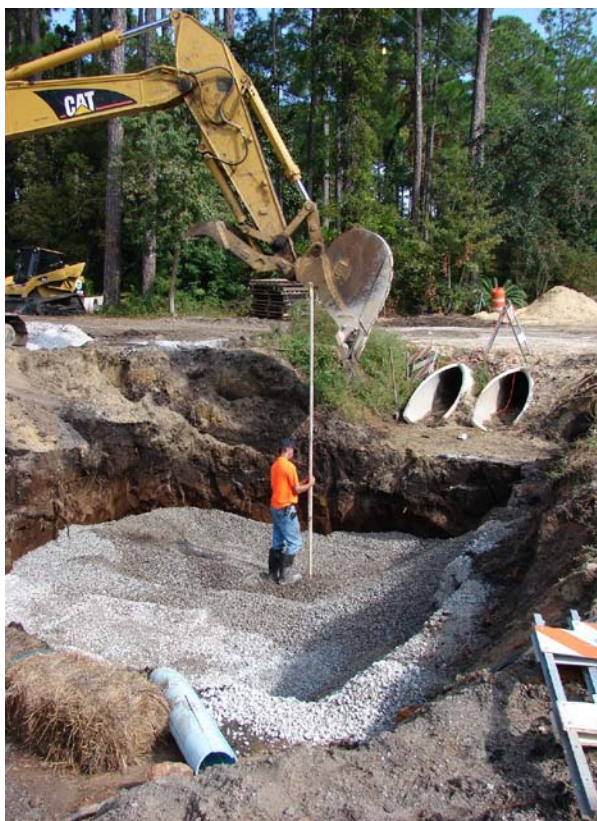
A gravel rock base was prepared to provide a stable surface for the box.

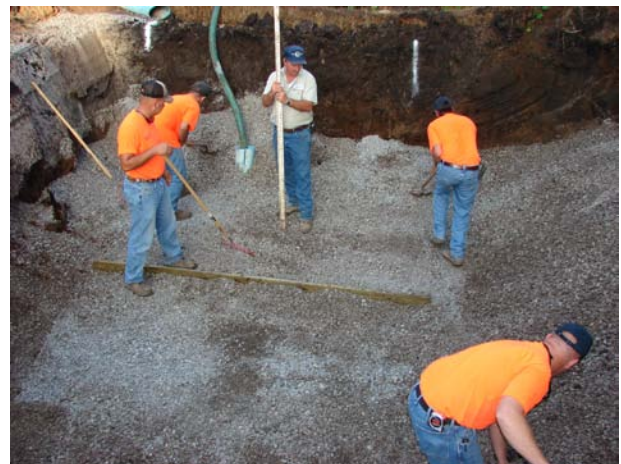
Gravel base being leveled. Note the well point in the background that kept site dry.

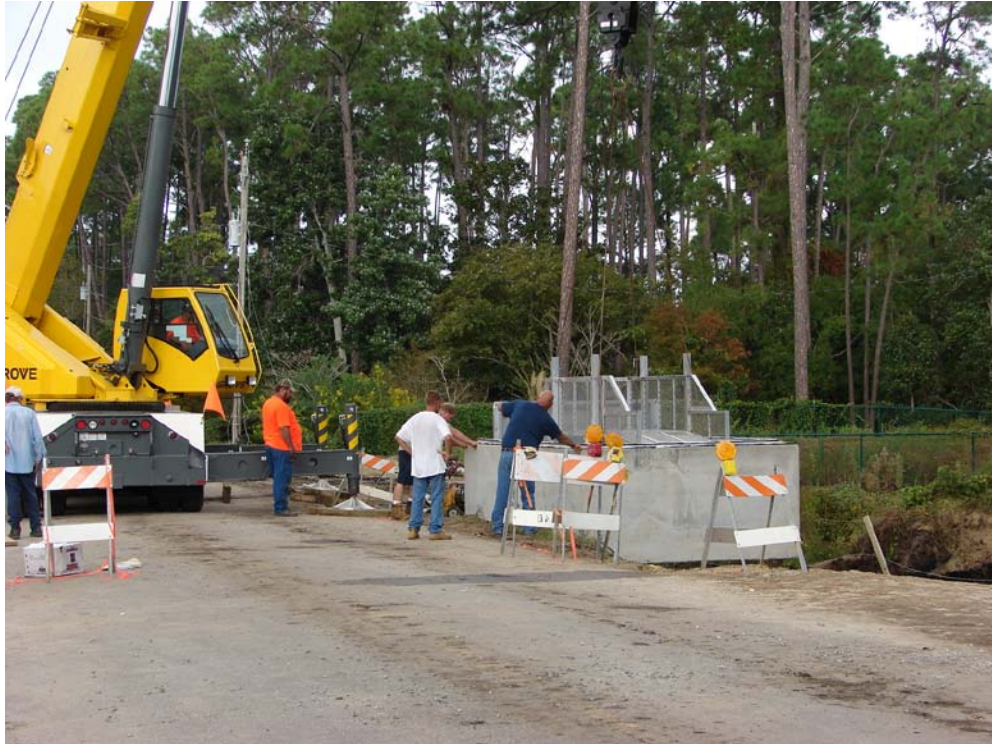
A crane was needed to install the base unit and screen assembly.

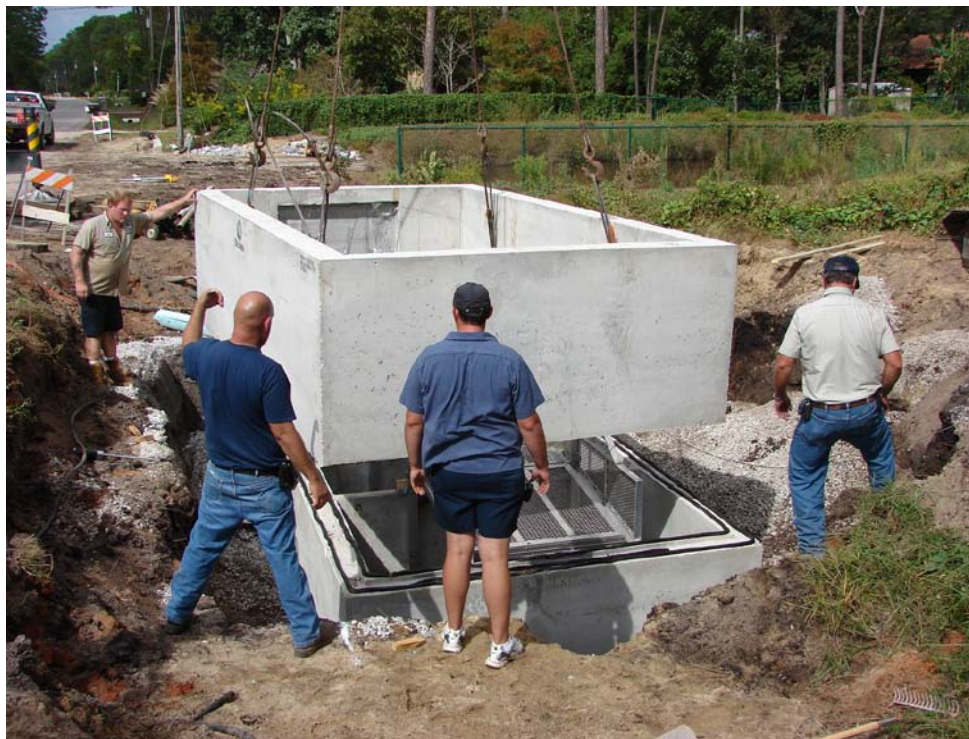
The crane was also needed to install the upper section of the box. Note the beads of sealant around the seam where the two halves meet.

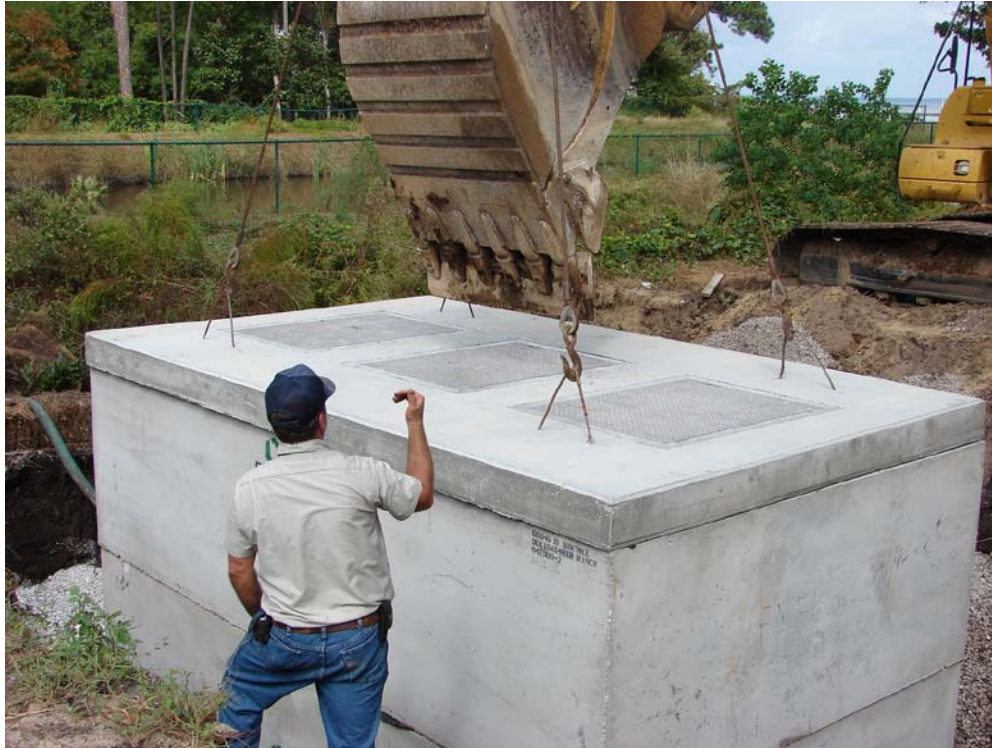
The lid for the baffle box was installed using a large back hoe.

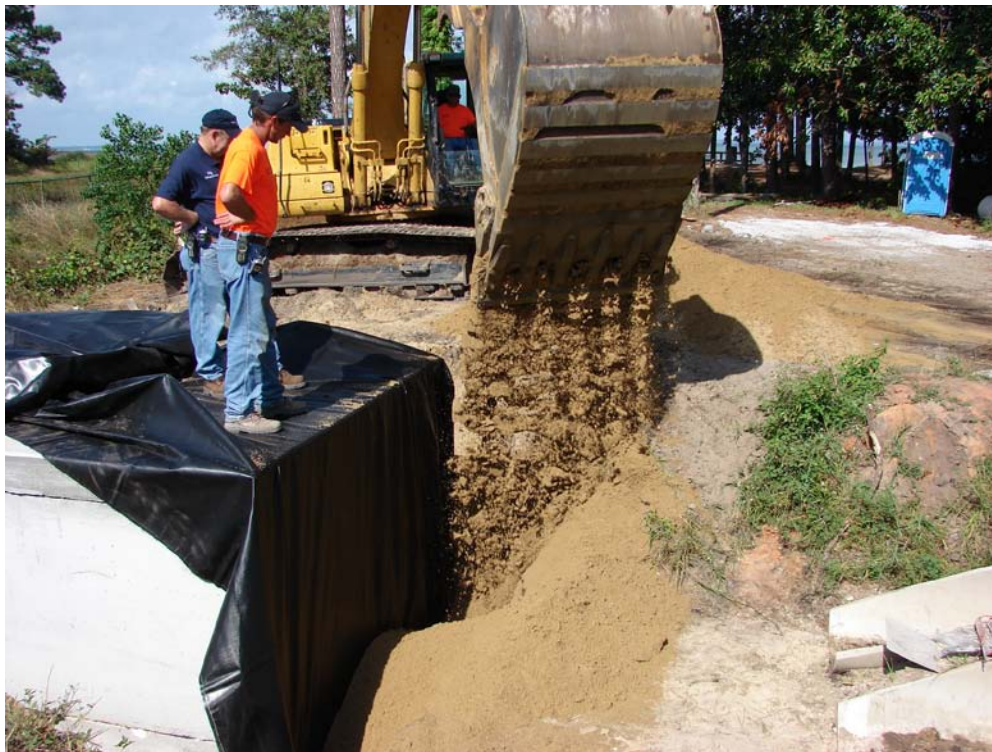
The back hoe was also useful for backfilling around the box.

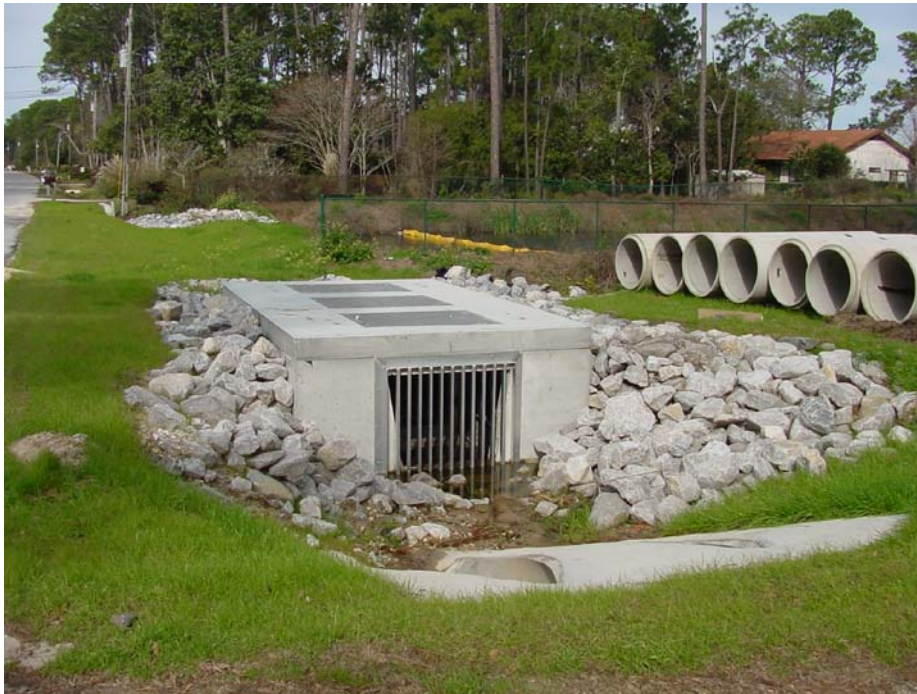
This is a view of the rip-rap that was installed around the box.

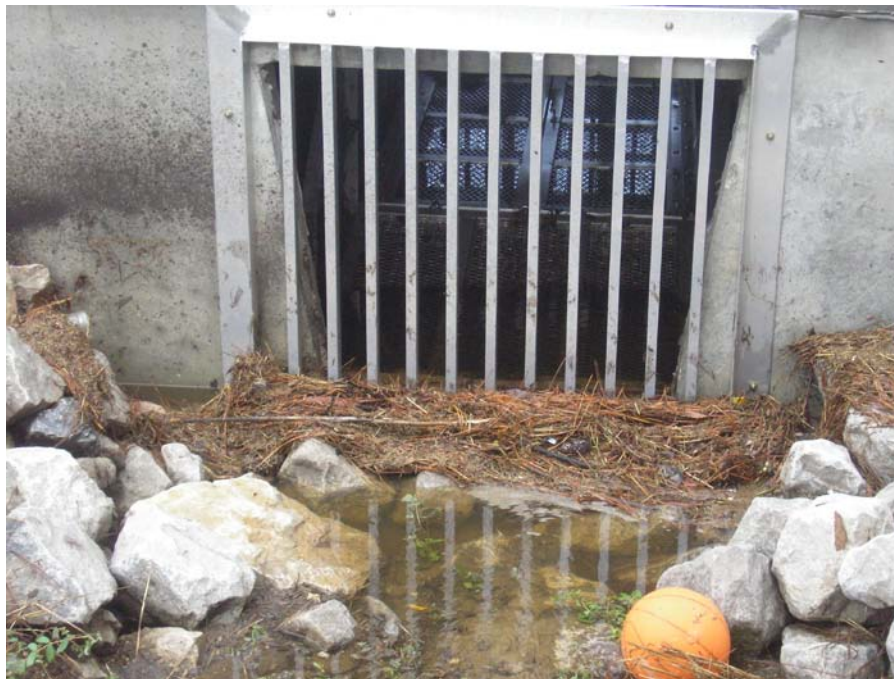
A vertical grill was installed to keep children and pets from becoming entrapped in the box but it collected too much debris and caused the swales to backup. This nearly caused a serious flood. The grill was removed and re-installed horizontally with about one foot of clearance at the bottom to allow for runoff to pass freely through the system.

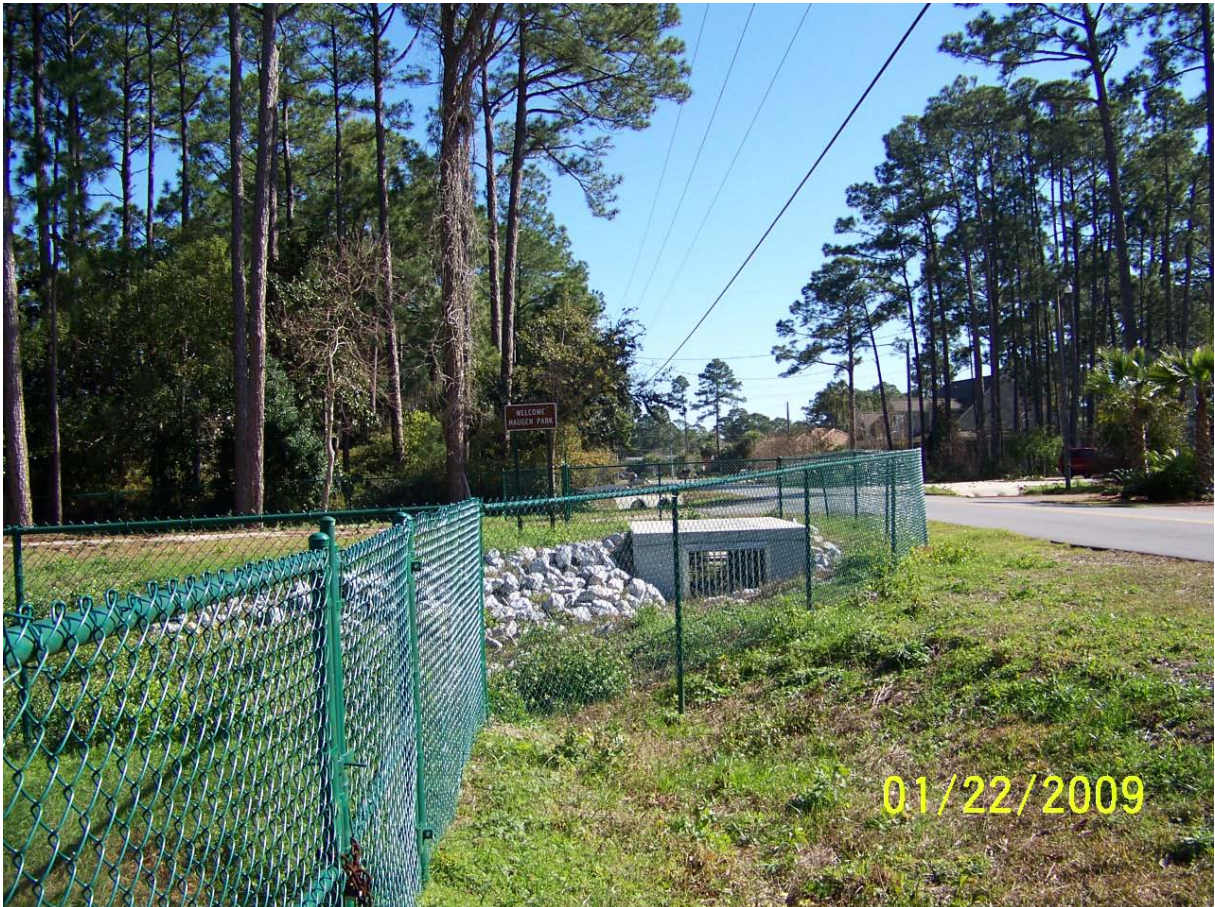
The completed Baffle Box at Haugen Park on Shore Drive where treatment is provided for all of the runoff from sub-basin 1 prior to it being discharged through an existing swale to the outfall from the Park to Choctawhatchee Bay.

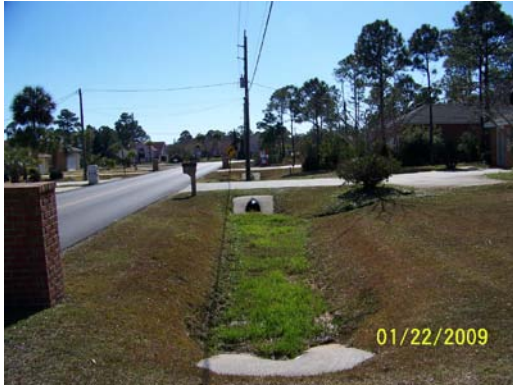
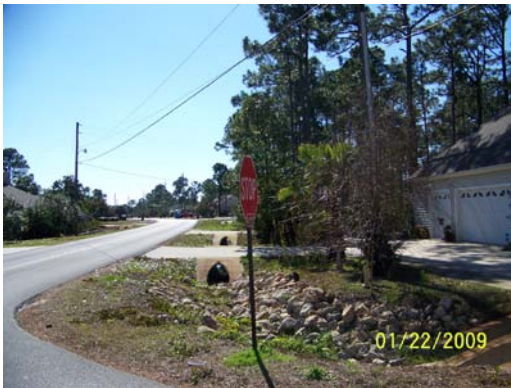
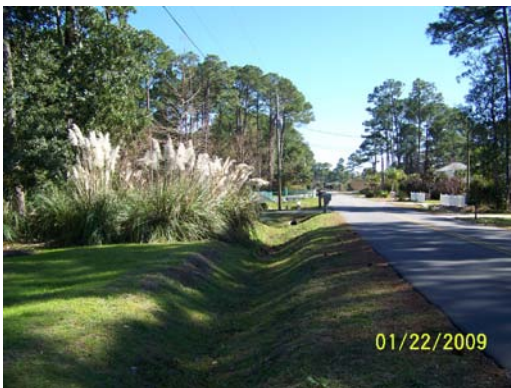
## Construction and Post Construction for Sub-Basin 2

As was done for sub-basin 1, swales were constructed and culverts ranging from 18 inches to twin 30s were installed to convey runoff to Haugen Park. In this case, treatment is provided by a wet detention pond rather than a baffle box as was used for sub-basin 1.
