# **HOLIDAY SHORES STORMWATER RETROFITTING PROJECT**

DEP AGREEMENT S0098 FINAL REPORT – JANUARY 2009

CONTRACTOR:  
WALTON COUNTY PUBLIC WORKS DEPARTMENT

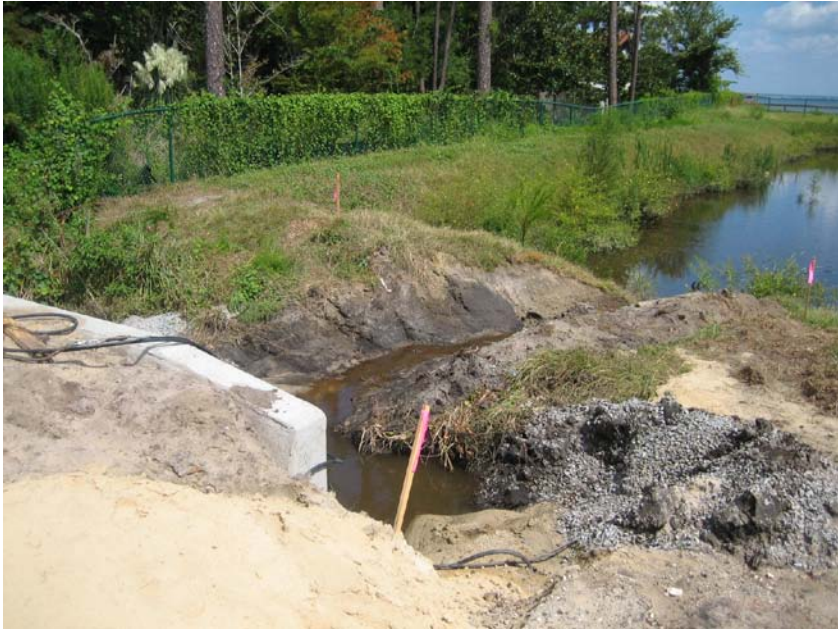
This is the inflow location for the wet detention pond prior to being rip-rapped or the diversion weir and the by-pass being installed.

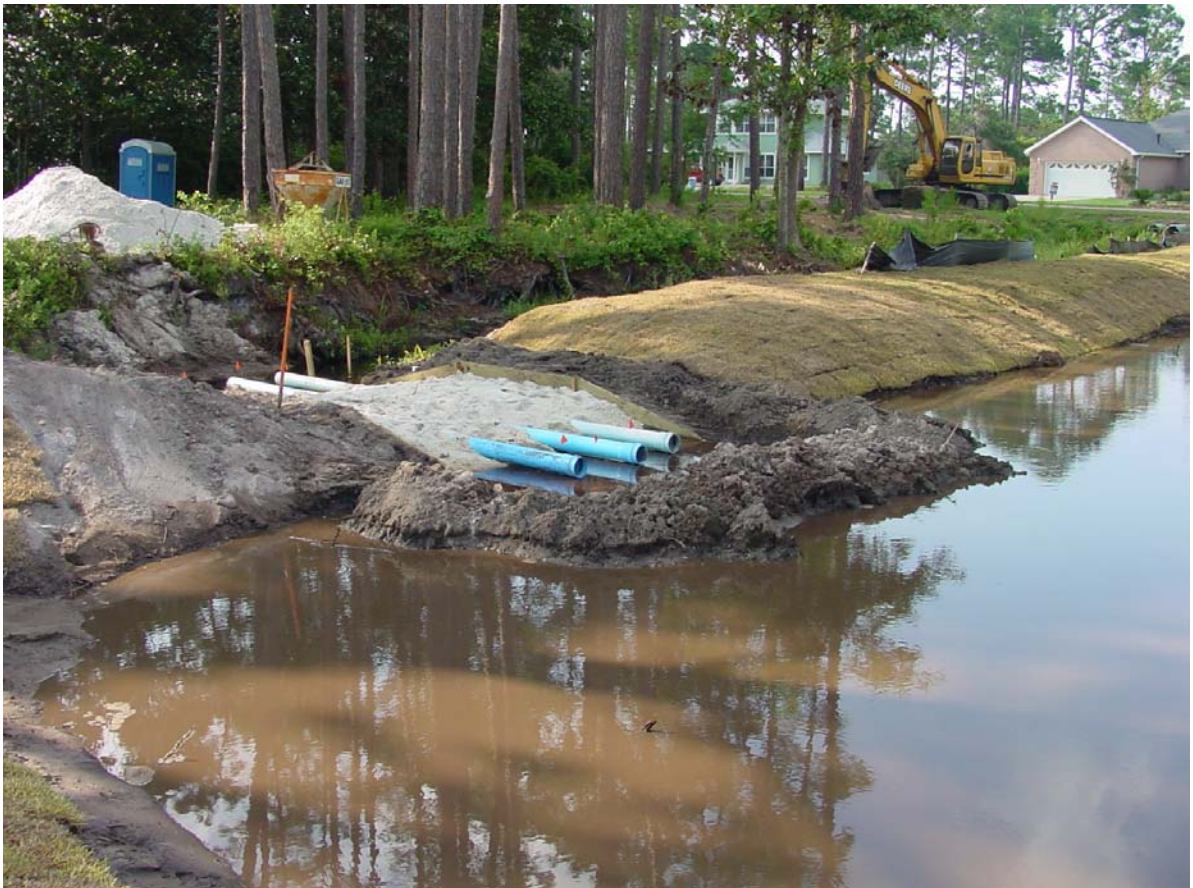
This is the outfall weir of the detention pond under construction. Three six inch PVC bleed down pipes are shown.

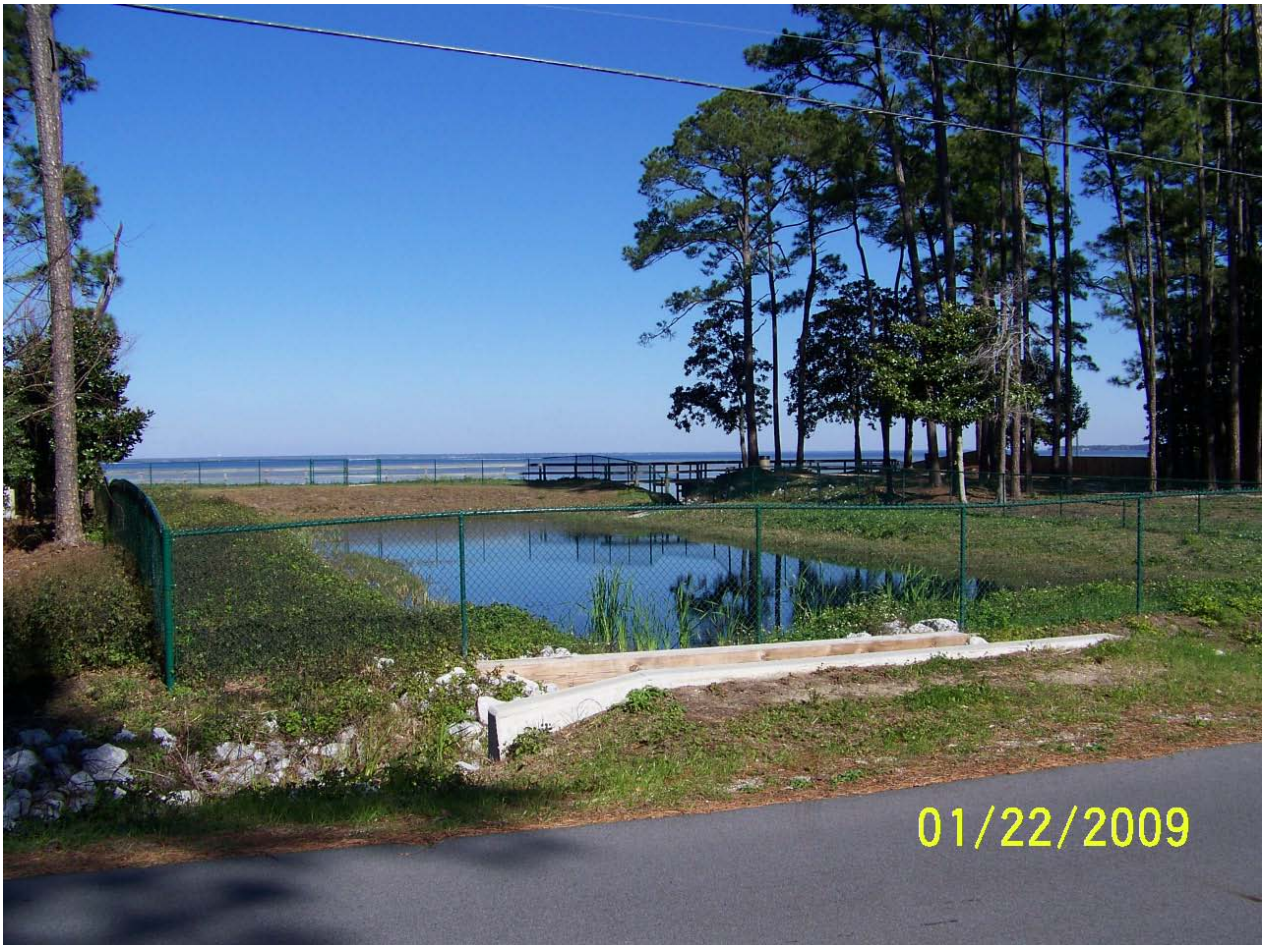
This is the view looking north towards Choctawhatchee Bay of the completed wet detention pond that was constructed in Haugen Park on Shore Drive to provide treatment for the runoff that is discharged from Sub-basin 2. The pond is located just slightly west of the baffle box that provides treatment for sub-basin 1. They both discharge to an existing swale that transects Haugen Park.

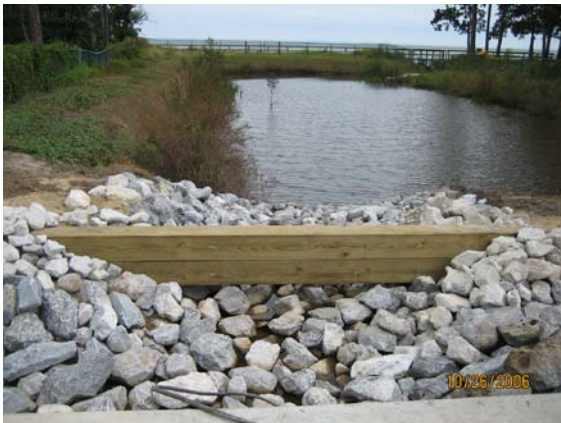
This is the diversion weir that was constructed to direct excess runoff around the pond. The bypass was added as a change order to provide the maximum amount of detention and treatment of the first half inch of runoff and avoid overloading the system hydraulically.

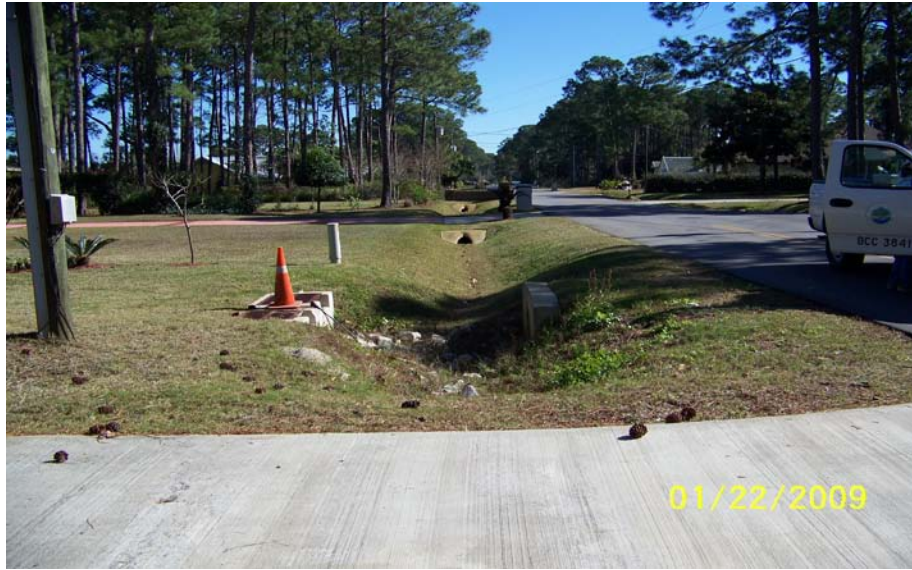
View of the contributing watershed and reshaped vegetated swale on Shore Drive looking east from the control structures in sub-basin 3 during dry conditions.

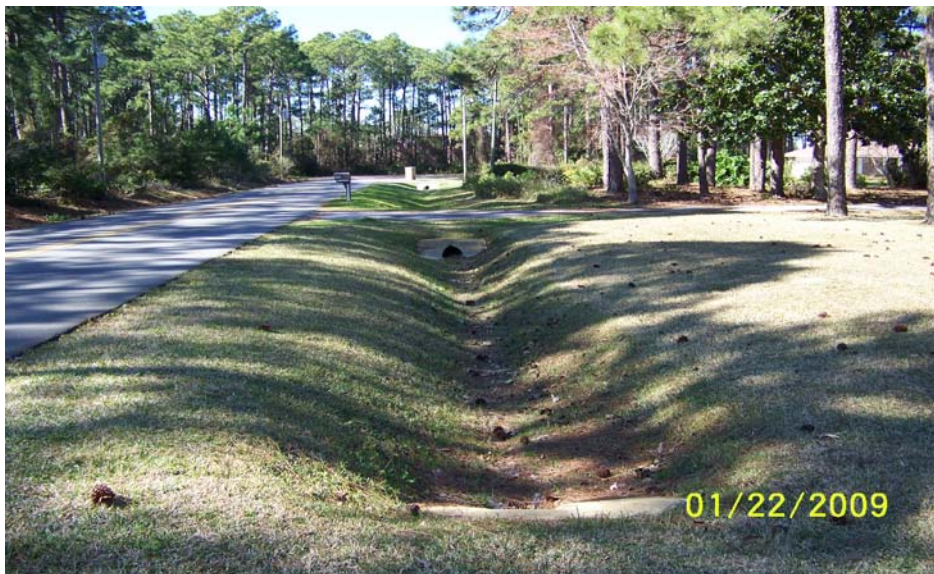
View of the contributing watershed and reshaped swale on Shore Drive looking west towards the cul-de-sac from the control structures in sub-basin 3 during dry conditions.

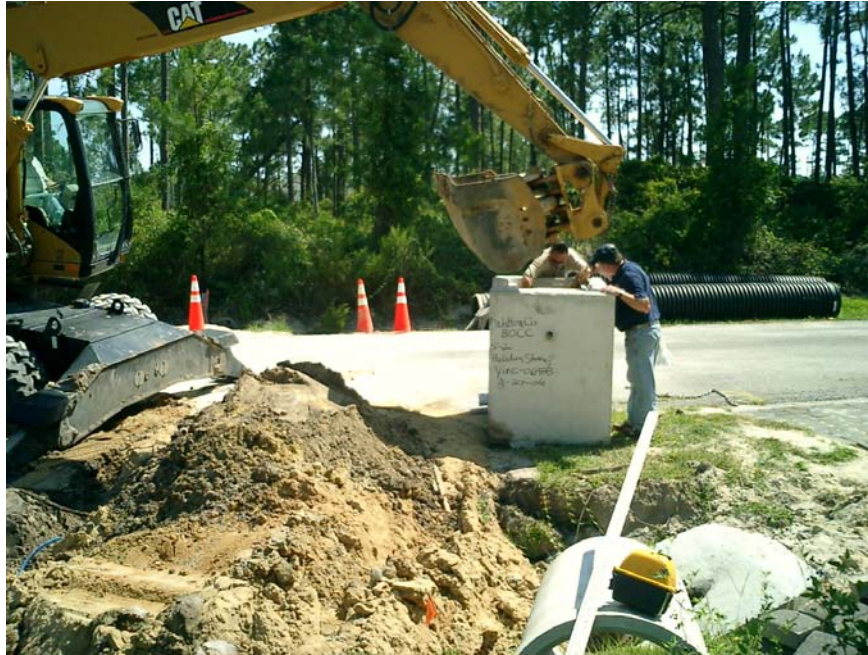
Control structure being set for sub-basin 3.

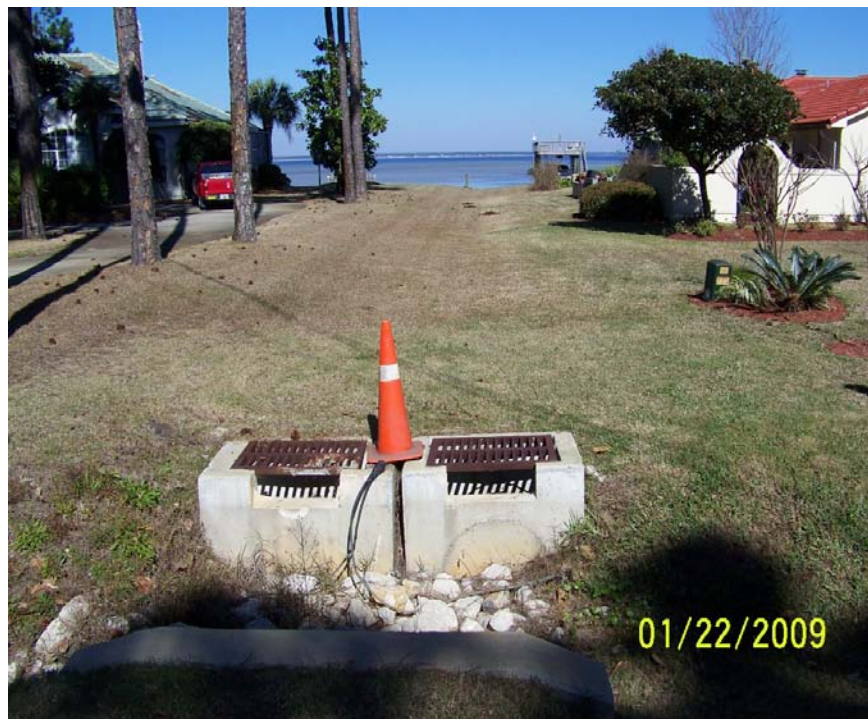
View looking north towards Choctawhatchee Bay at the outfall control structures for sub-basin 3. These structures increase the amount of detention provided in the swales. Storms that generate more than the design volume of runoff top the weirs and discharge to the Bay through a double row of 18" flex pipe. A wide swale in the right-of-way provides an emergency overflow for extreme storm events. Bleed down occurs slowly over several days through perforated six inch PVC pipes at the base of the structures

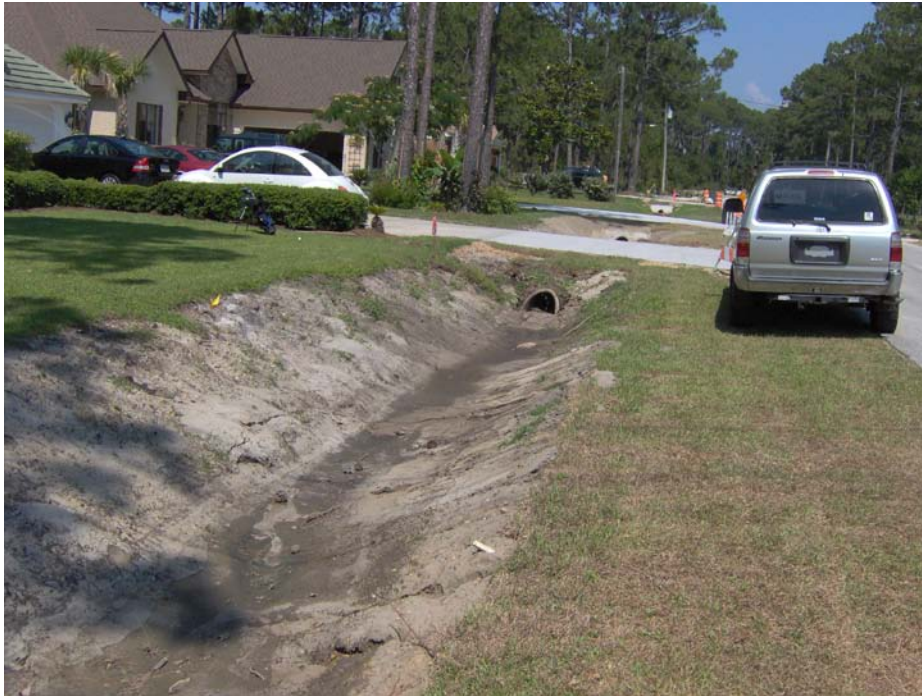
A swale recently constructed and ready for sod to be installed. Swales provide positive conveyance to outfalls and treatment of runoff prior to discharge.

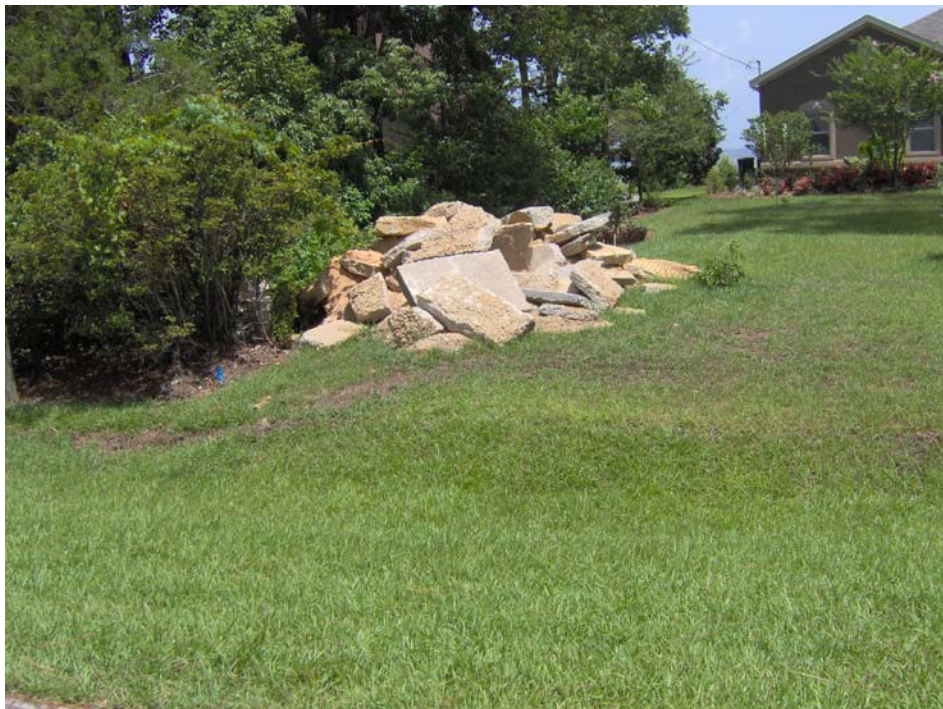
Concrete rubble that was generated when existing driveways were demolished was used to stabilize seawalls and provide habitat along the shoreline.

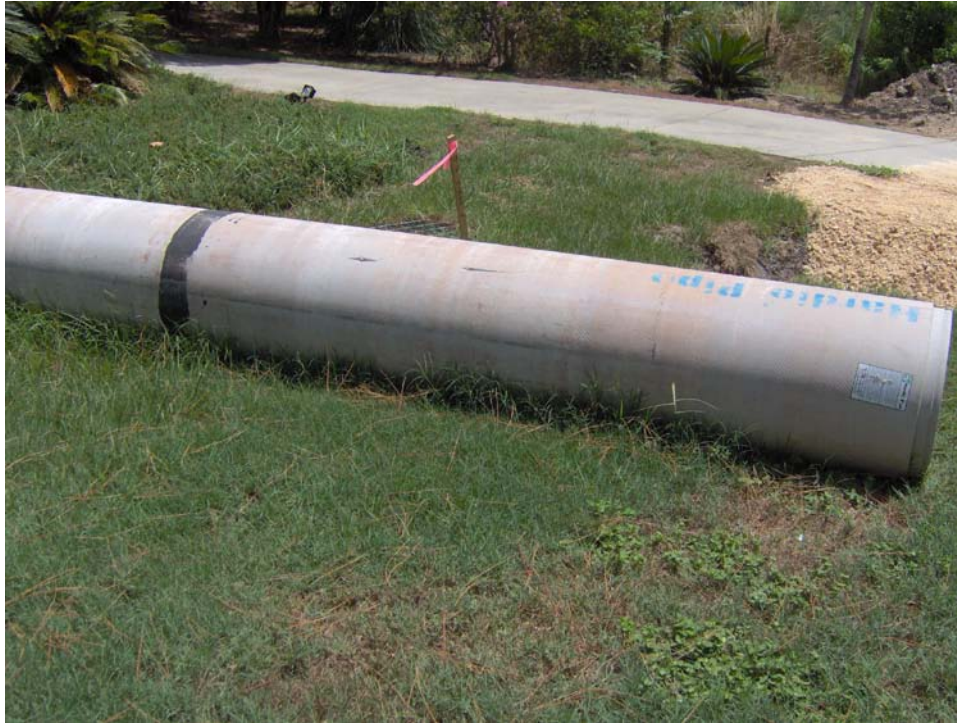
High quality reinforced concrete pipe was used throughout the entire project..

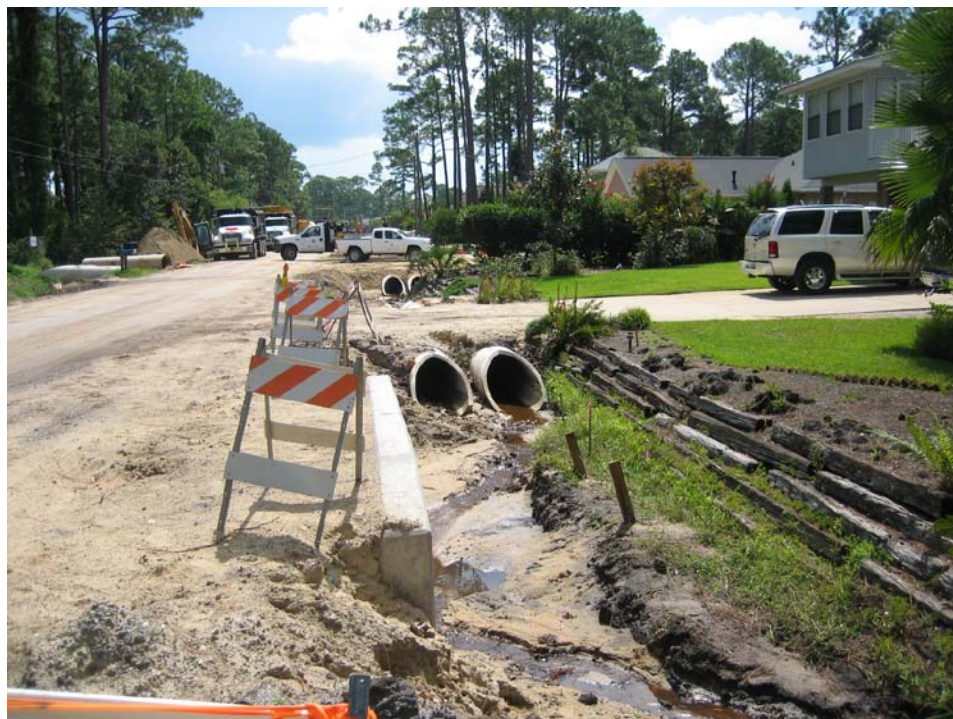
The headwall construction, pipe alignments, and rip-rap at this location where the conveyance for sub-basin 2 passes underneath Shore Drive was done in a manner that allowed a resident to keep the landscape timbers and landscape buffer shown above.

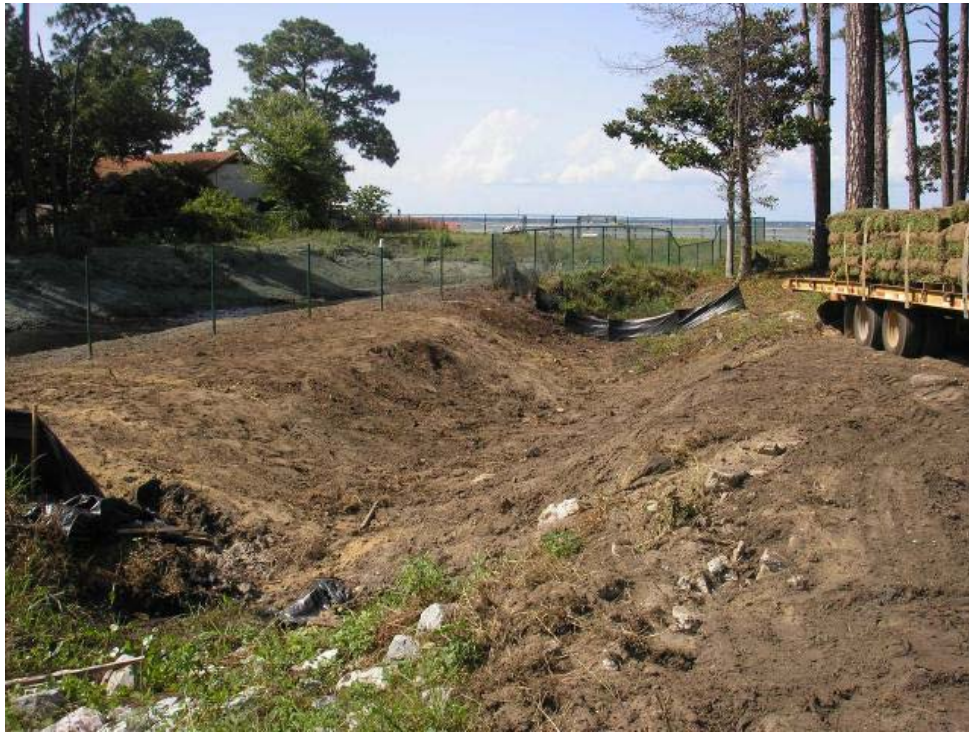
This is a view of the swale through Haugen Park which the baffle box and the wet detention pond discharge to. This swale connects directly to Choctawhatchee Bay.

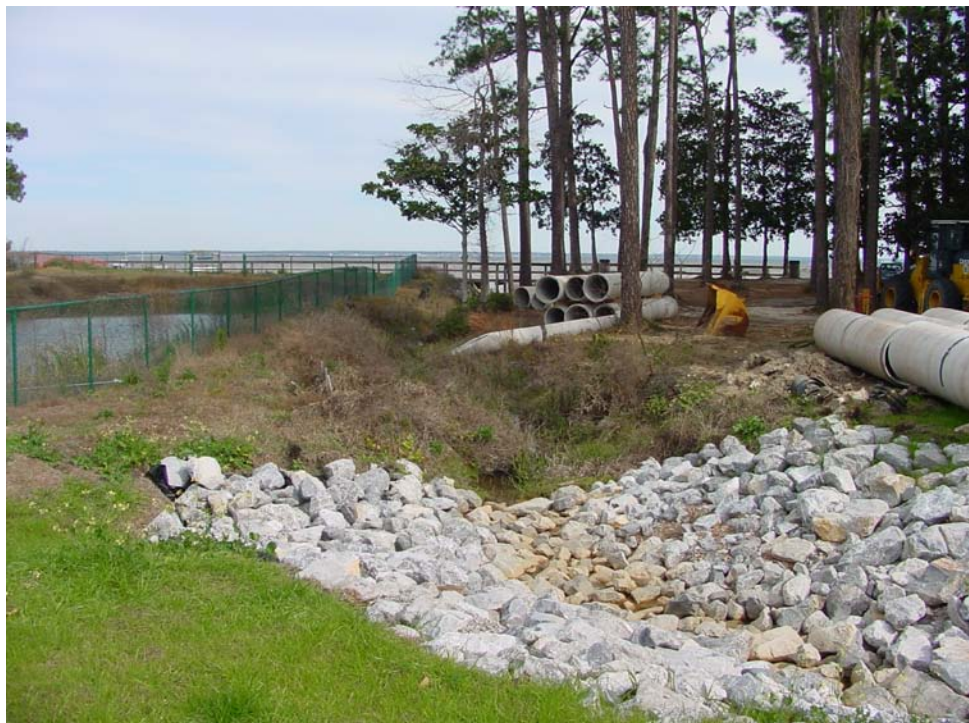
This is a view of rip-rap that was installed to prevent erosion at the head of the swale where the wet pond bypass channel and the baffle box outfall converge.

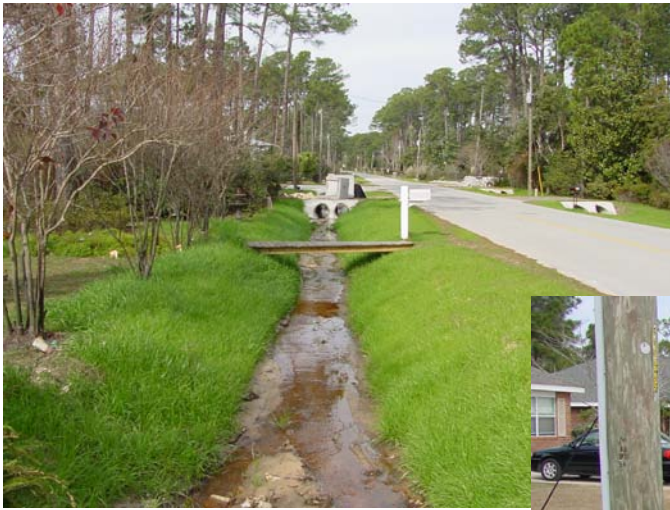
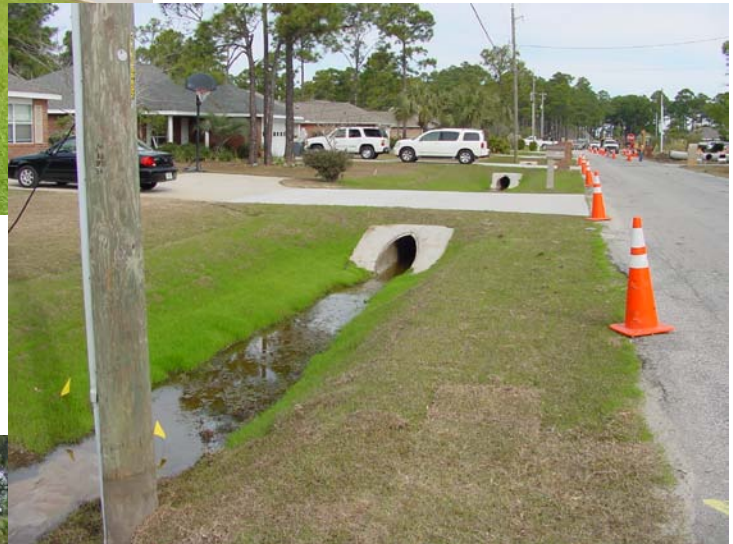
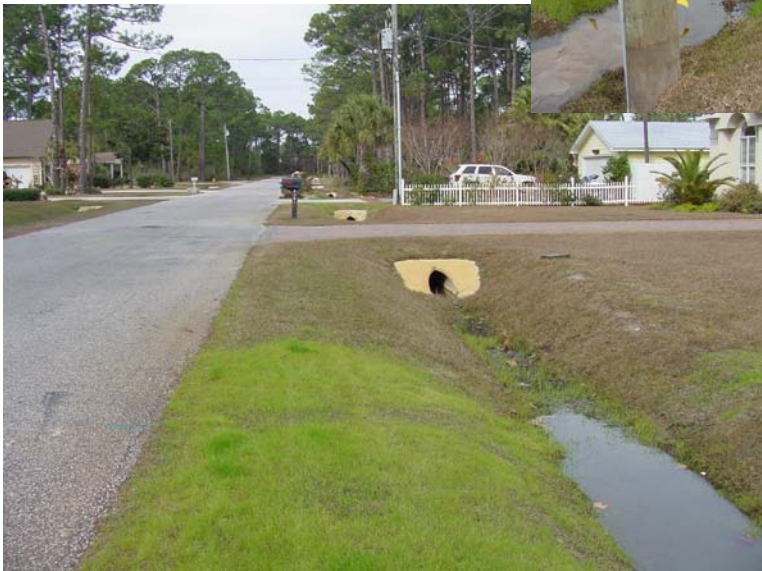
As the project was being finished a high water table kept the bottom of the swales wet for a prolonged period and raised concerns that vegetation would never get established. Planting wetland species throughout the swales or rip-rapping them was considered in order to prevent erosion. However, residents clearly preferred a manicured look and would not accept having wetlands and snakes in front of their homes and rip-rap was not aesthetic either. Fortunately, the water table receded and acceptable vegetation became established.

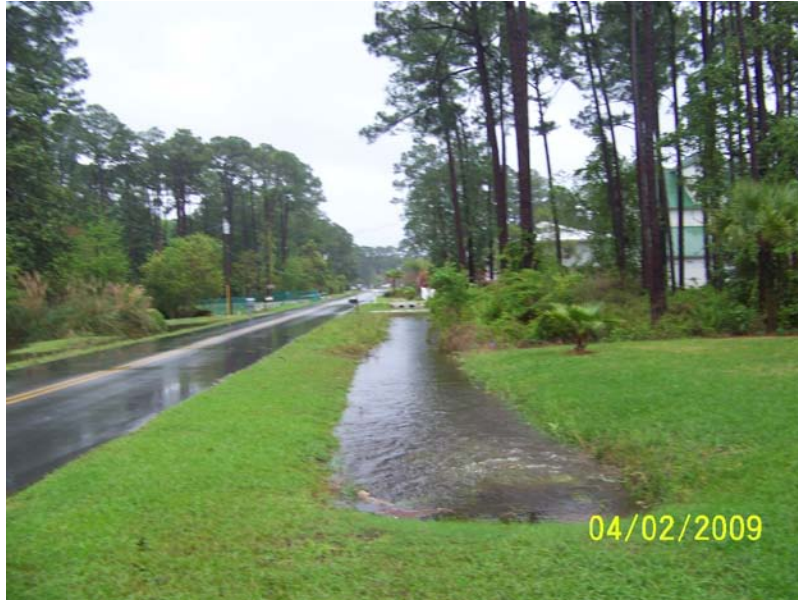
This is a swale in sub-basin 2 near the outfall to the wet detention pond at maximum capacity but still in bank following a major storm event.

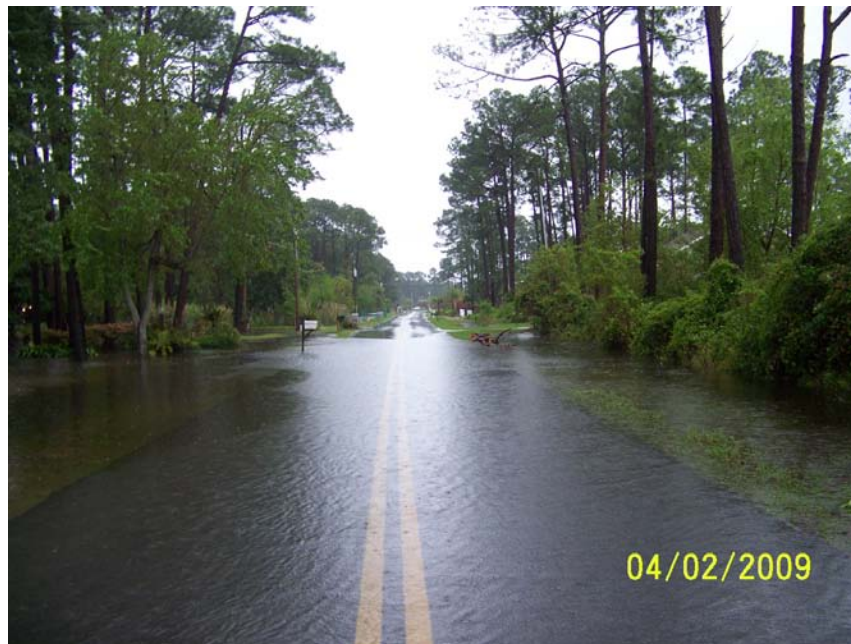
This is after the same storm event at an unimproved location along Shore Drive where the swales were over topped and flooding occurred.
