## Energy Efficient Renovations Of Storm Damaged Residences - Florida Case Studies

# Energy Efficient Renovations of Storm Damaged Residences - Florida Case Studies

**FSEC-CR-1648-06**

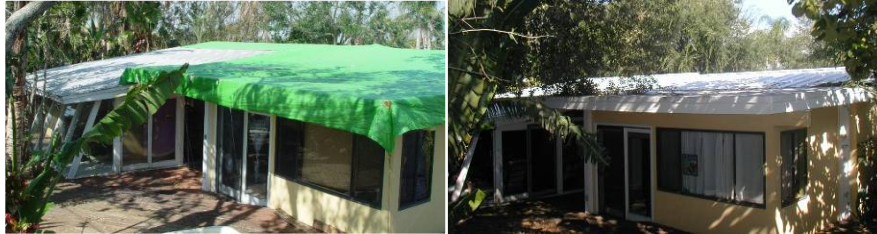
## 2.1 Home A

Most of the damage caused to the home during Hurricane Frances was due to failure of the roof covering subject to high winds, and subsequent rainwater intrusion. One flat roof section was stripped bare to the plywood decking, and there were a large amount of damaged and missing shingles. Extensive water stains were apparent on the ceiling drywall in every room when the homeowners regained access to the home after the storm. In two rooms, large holes eventually formed in the ceiling as the heavy, wet drywall failed under its own weight. A number of recessed can light fixtures and ceiling fans were also damaged due to the water. In addition, some of the water that leaked through the roof flowed down the trusses to where they meet the exterior concrete block walls, and flowed down behind the drywall where it pooled on the floor, ruining carpet and baseboards.

After an inspection by an insurance adjuster, the original plan was to replace the entire roof covering, any damaged roof decking, and to cut out and patch damaged areas of the ceiling and wall board. The long lead time encountered to get the roof replaced led to additional mold growth on the ceiling drywall. As a result, the owner decided to replace entire ceiling. Old blown in fiberglass and fiberglass batts were removed and the owner took advantage of this opportunity to converted the attic to an unvented type using BioBased foam. Rather than replace the roof covering with shingles that only have a life expectancy of 15-25 years, the owner decided to utilize white standing seam metal on pitched areas of the roof with a 50 year life expectancy. For the flat roof areas, rather than using a roll roofing, built up covering, or bituminous covering with a life expectancy of 5 years, the owner used a 10-year system that includes 1" of closed cell foam sprayed on the exterior of the flat roof decking which was then

covered by reflective silver colored, spray applied, coating to protect the foam from UV deterioration.

In addition, 85% of the existing incandescent lighting was converted to fluorescent by removing all recessed can lights and installing Energy Star Gossamer Wind ceiling fans with light kits and other Energy Star fixtures and bulbs. Damaged carpet was replaced with laminate cork flooring.

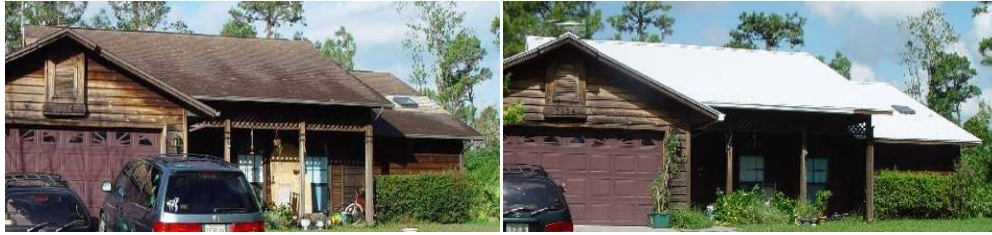
## 2.2 Home B

This 1,700 square foot home in Cocoa, Florida was damaged by hurricanes Frances and Jeanne. A white metal roof was chosen to replace the damaged shingles to reflect summer heat and thereby reduce cooling energy use. The shingles were not removed but left in place below the newly installed metal.

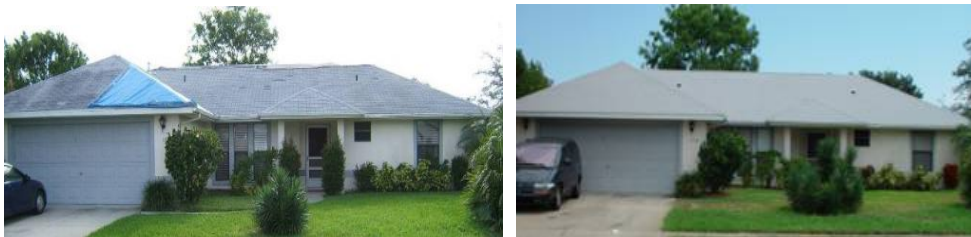
## 2.3 Home C

This 1,960 square foot home in Rockledge, Florida was the least damaged of the four houses chosen in this evaluation. There was loss of shingles, but only a small amount of water actually came through to the ceiling. The damage to the ceiling was slight and when allowed to dry, only needed to be repainted. The fiberglass insulation in the attic was not affected either. The replacement roof for this home was purchased and installed by the homeowner. The original dark, 3-tab asphalt shingles were removed and replaced with white ones.

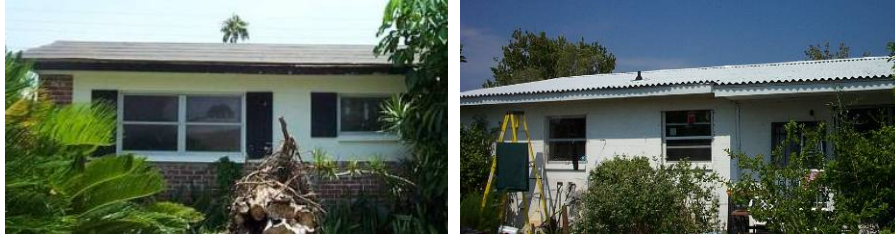
## 2.4 Home D

This home was the most severely damaged of the four buildings in the analysis. A section of the rear portion of the roof was destroyed allowing water to enter into the dwelling which resulted in severe damage to the interior. As a result, the interior had to be completely demolished and rebuilt per recommendations. This retrofit included light roof color, unvented or sealed attic, sealed air distribution system, higher efficient heating and cooling system and double pane low-e windows. In addition, the gas water heater that was located within the conditioned space was replaced by an electric unit (there were 2 primary reasons for the replacement -1) age of the unit and 2) the electric unit did not require combustion/dilution air).
