Energy and Resource Assessment of the Caribbean Marine Research Center, Lee Stocking Island

Danny S. Parker and Michael P. Callahan
Florida Solar Energy Center (FSEC)

FSEC-CR-1085-99

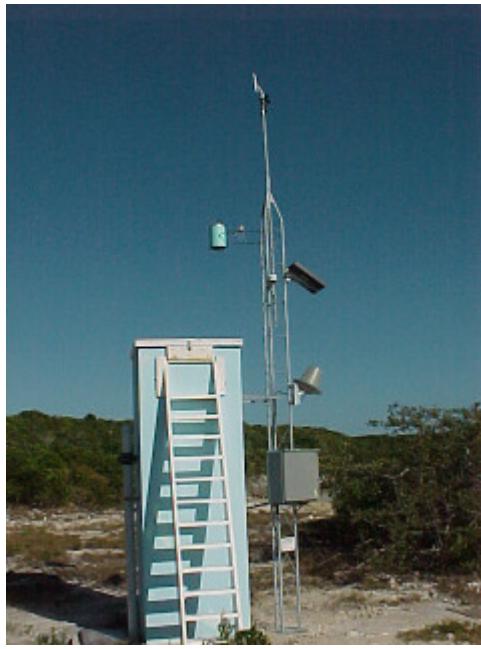
A meteorological station is located on the island as part of the Caribbean Planning for Adaptation to Global Climate Change (CPACC) project. The station collects data including temperature, humidity, wind speed and rainfall. The data is theoretically available over the Internet from its satellite downlink, but the data transfer seems unreliable and can not be easily obtained. However, since 1990 CMRC has maintained its own weather station (Figure 3) to collect meteorological data and a summary of the month-by-month averages from the last year is given in Table 1. The weather is warm, but dry with considerable wind (prevailing wind direction is from the southeast).

Figure 3. Weather station at CMRC.

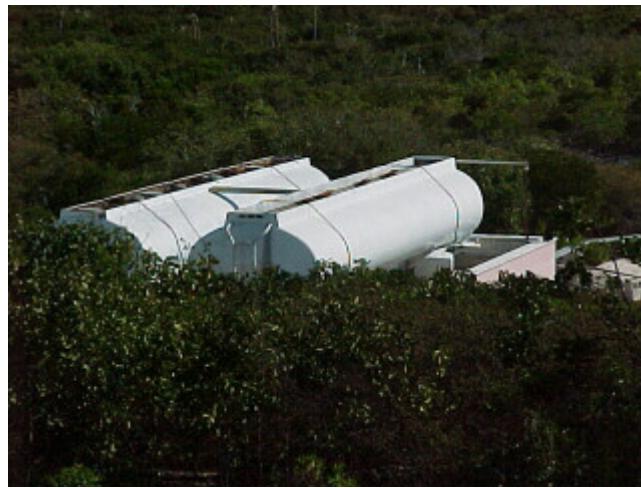
Fuel is available in two large storage tanks (Figure 4) which hold roughly 12,000 gallons of diesel fuel and 4,000 gallons of gasoline. Diesel fuel cost is approximately \$1.00 per gallon (duty free).[\(4\)](#) Gasoline is used primarily for boats (CMRC maintains 10 boats). The storage tanks are re-fueled every six weeks.

Figure 4. Diesel fuel storage tanks.

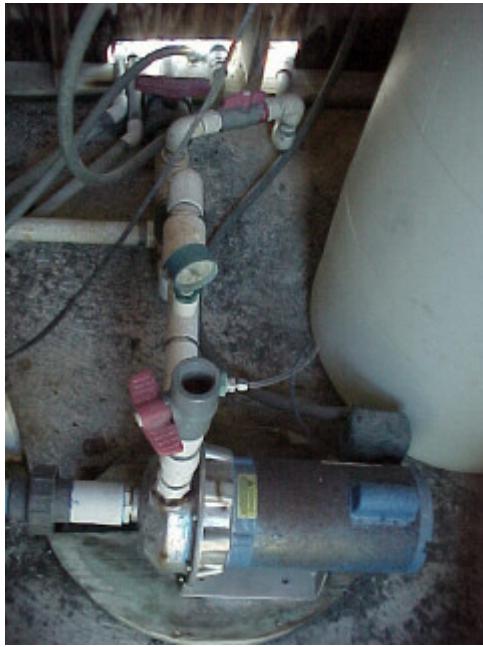
Seven AC pumps (Table 4) are used about the island to maintain water pressure at the various buildings. Typically these are A.O. Smith 3/4 hp pumps (C48KDB11A16) which draw 5.7 amps at 230 volts (Figure 10). The large number represent a significant load:

Figure 10. Distribution pump.

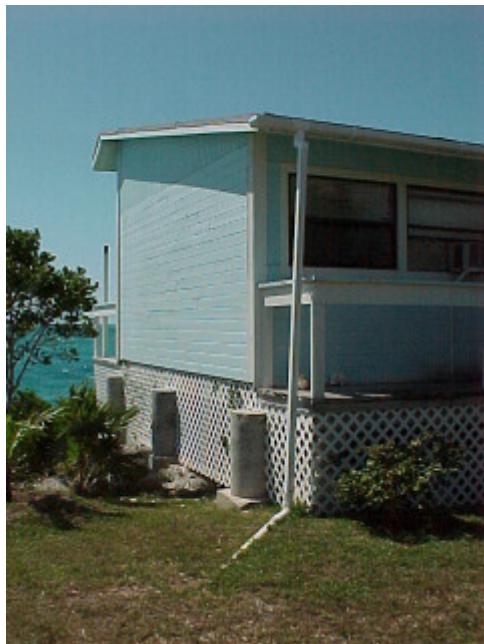
Figure 12. Gutter system on the VIP quarters that feeds rain water to the cistern by the commissary.

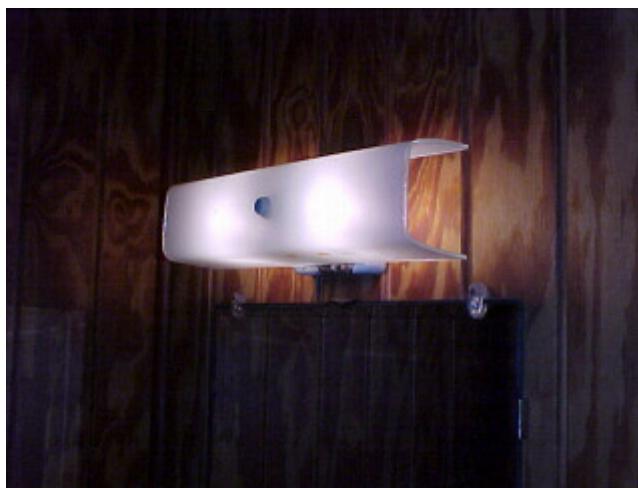
All lighting at LSI are conventional incandescent or halogen lamps. These are very inefficient. Lights are commonly left on, particularly in the lounge area. There are also a number of overhead lighting systems with T-12 lamps, which are inferior to newer lamps (T8s) in performance. Lighting is more than adequate. For example, every VIP bathroom has a sink light (Figure 21) and shower light, and two lights in the "rec room," as well as a table lamp. There are adequate windows in almost every building to take better advantage of daylighting.

Figure 21. Bathroom sink fixture.

Recommendations: Replacement of all incandescent light bulbs with compact fluorescents (CFLs). The Panasonic SL15 lamp will fit most places which an incandescent will and gives the light of a 60W incandescent for 15W and lasts 10,000 hours rather than the 800 hours for a conventional bulb. These lamps are available in both a standard and globe configuration and cost about \$15 each when purchased in quantity. This will reduce maintenance requirements.

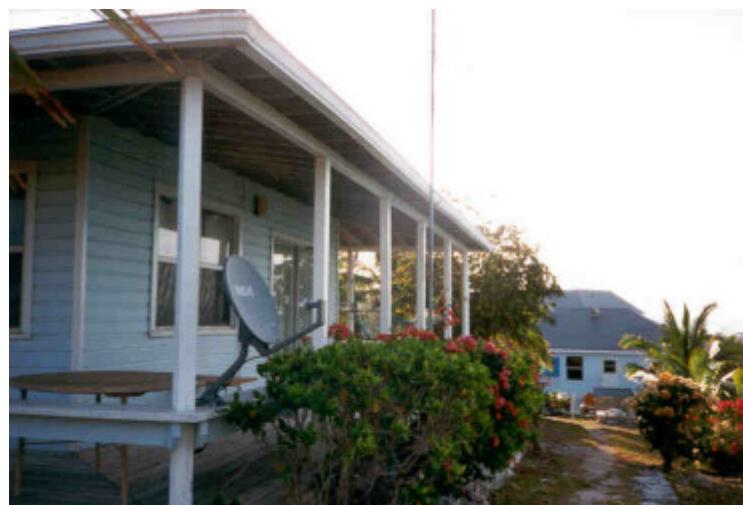
Figure 28. Eight foot surround porch overhang of one of the residences.

New residential construction should follow recommendations as before: concrete block walls, white reflective concrete roof, and energy efficient features. Integral cistern systems should be provided for all new construction. Cooling systems should remain the window/wall type to simplify maintenance. All lighting in kitchens and baths should be T8 fixtures with electronic ballasts or CFLs. In addition to these measures, residences should be constructed similarly to the Hilltop house, with large porches and overhangs that surround the entire building. This will shade the windows and walls and reduce air conditioning.
