POPPLETON CREEK WET DETENTION POND

DEP CONTRACT NO. S0278

Cape Canaveral Scientific, Inc.
220 Surf Road
Melbourne Beach, Florida 32951

City of Stuart
121 SW Flagler Ave.
Stuart, Florida 34944-2139

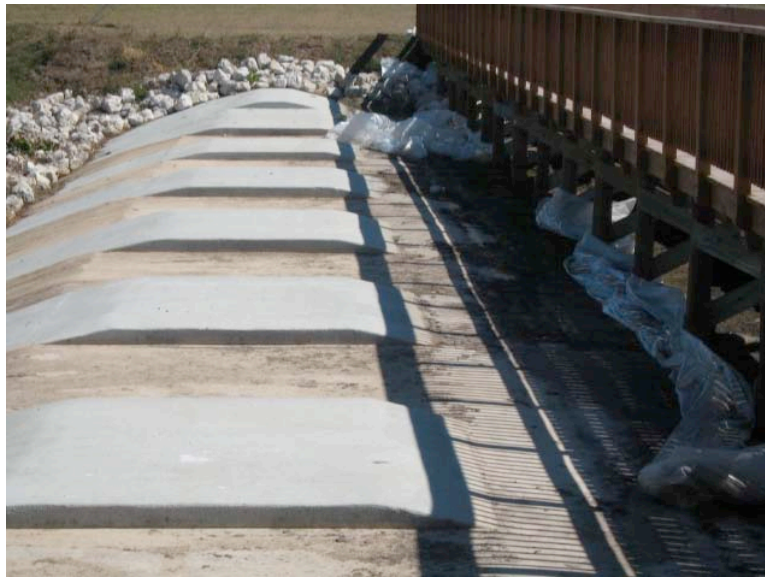
Figure 5
Outfall Weir for Pond

Bleed down to the control elevation of 6.0 was obtained through six 10-foot long notches formed in the concrete. See Figure 5. The downstream conveyance is a 30-foot wide earthen channel with a bottom elevation of 3.0. Concrete rubble and filter cloth were placed at the downstream foot of the weir to prevent scour of the earthen channel. The southwest corner of the site is shared with the Water and Sewer Division, where a new wastewater lift station was constructed to serve a force main running along Central Park Avenue and will also serve as the new site for a restroom facility. Access to the site is via a driveway at the southwest corner of the site, which leads to the lift station and a parking lot for the stormwater park. The parking lot is constructed of pervious concrete to enhance infiltration of onsite rainfall.

The normal water surface of the pond was at elevation 6.0, with the bottom of the pond at elevation -4.0, giving a pond depth of 10 feet. A 168-foot long, concrete, broad crested weir at elevation 6.5 controlled flow out of the pond. A sheet pile weir was driven under the weir to prevent seepage and piping of lake water under the weir.

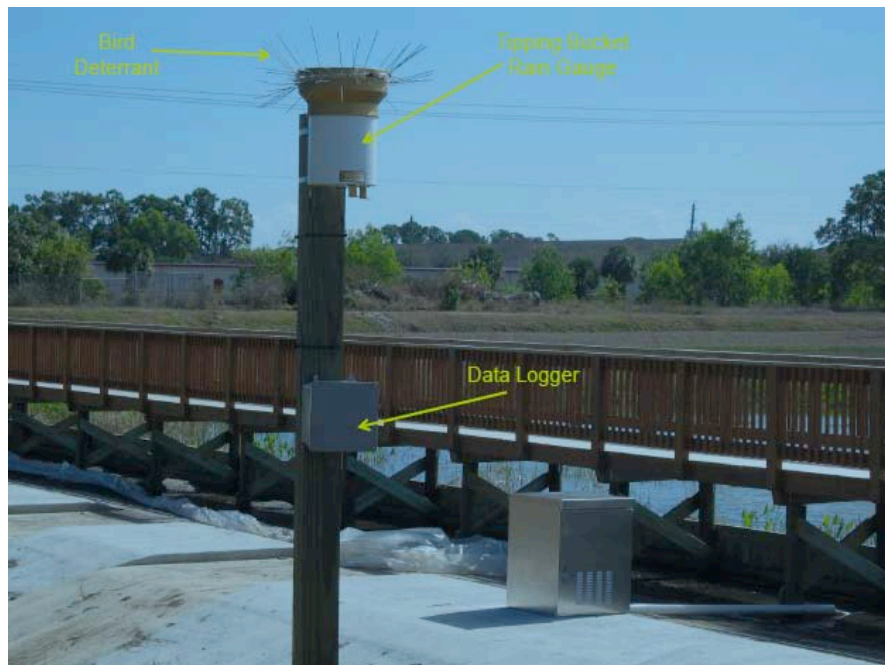
Figure 6, Outfall Autosampler on Weir

Prior to commencement of monitoring ERD prepared and obtained approval of the project QAPP that specified SOPs and protocols to be used. Figure 6 shows the Sigma Model 900M AX autosampler installed on the concrete outfall weir. These integral sequential samplers used an integral area/velocity flow meter to provide continuous flow measurements at 10-minute intervals into and out of the pond and to trigger flow-weighted inflow and outflow samples.

Flow measurements at the inflow ditch were performed using the area/velocity method with a flow probe. At the weir, overflow measurements were made using a pressure transducer sensor calibrated for the shallow water depth across the broad crested weir. The weir geometry was used to develop a discharge rate curve for the weir.
