Project SMART: A Restoration/Demonstration

RESTORATION/DEMONSTRATION

Martin Paul Wanielista, PhD
&
James Nelson Bradner, MS

December, 1992

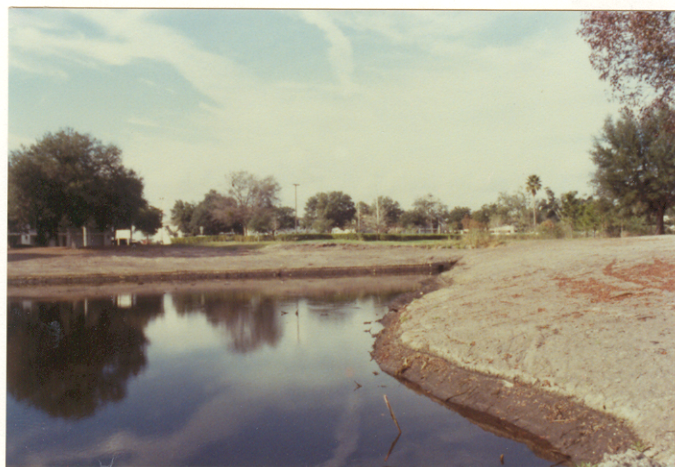
SHORELINE BEFORE
REVEGETATION

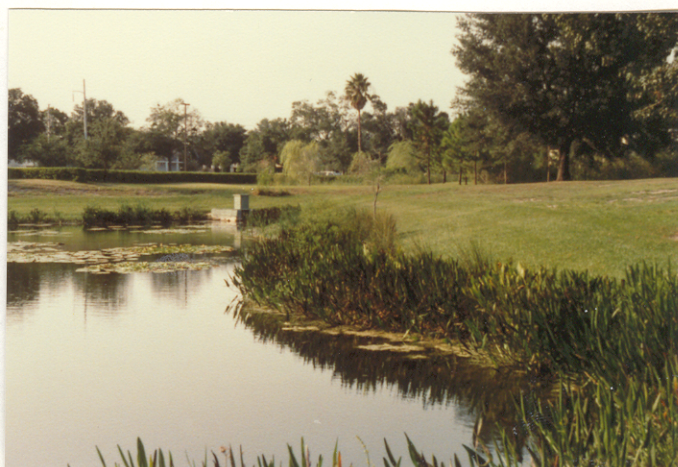
SHORELINE AFTER
REVEGETATION
